SUB: SUBMISSION OF STRUCTURAL AUDIT / SURVEY REPORT OF SIMLA HOUSE CHS LTD.

**STATUTORY STRUCTURAL AUDIT REPORT  
OF**

**SIMLA HOUSE CO-OPERATIVE HOUSING SOCIETY LTD.**

**51/B, NEPEAN SEA ROAD, MALABAR HILL, MUMBAI-400026**

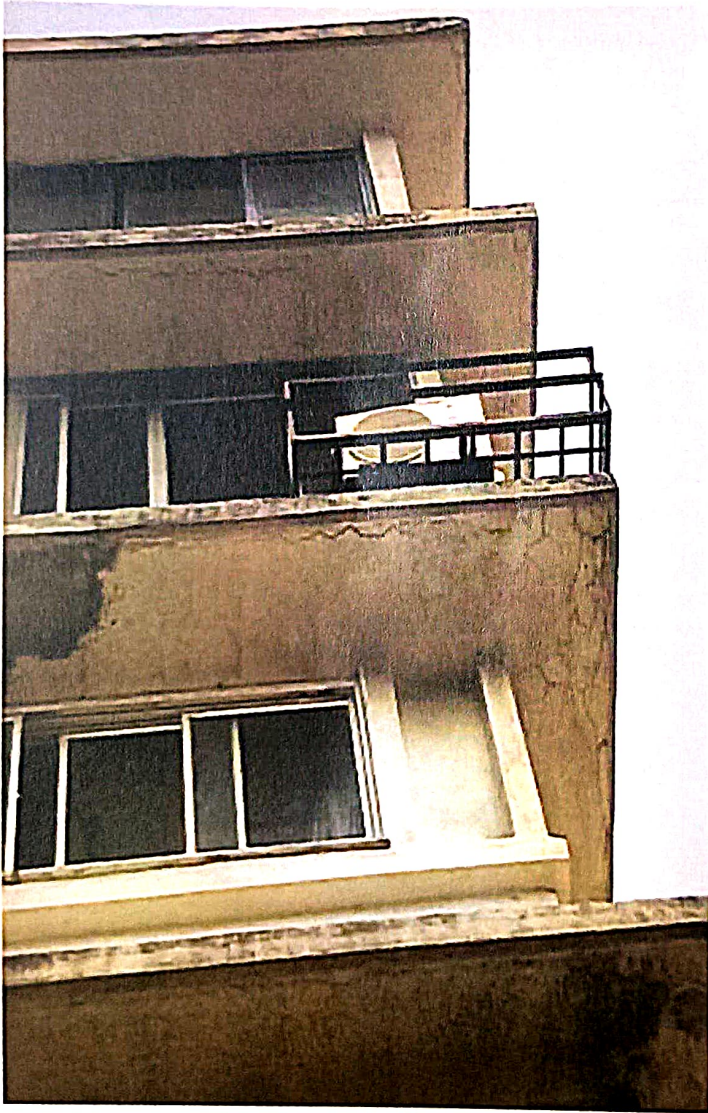
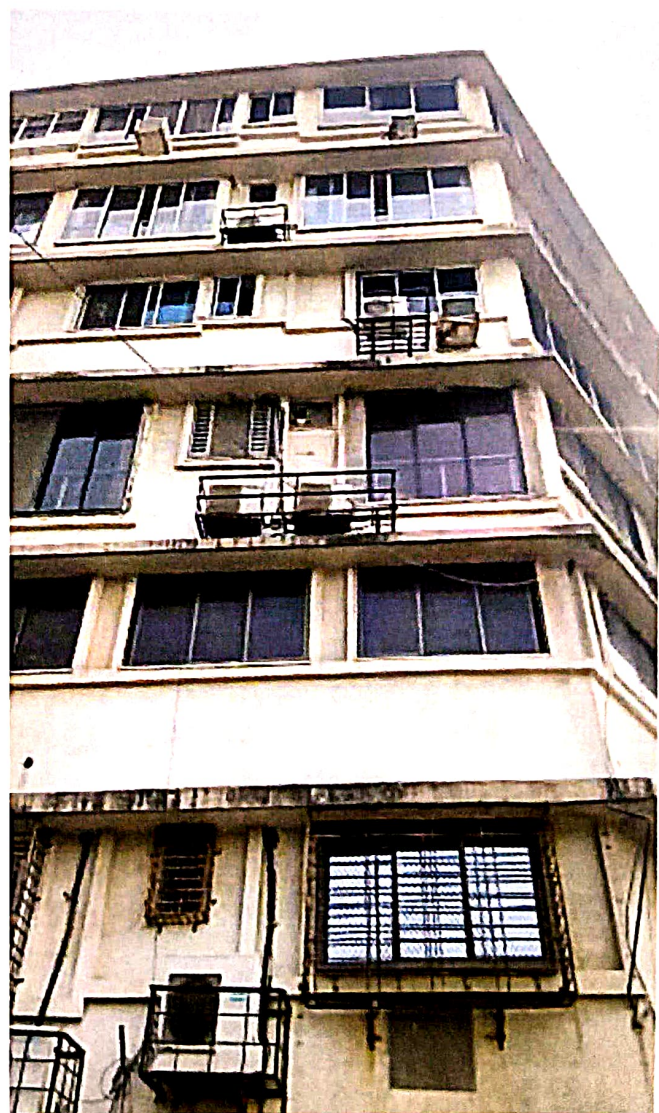
**LOT'S OF CRACKS DEVELOPED AT EXTERNAL SURFACE OF THE BUILDING.**

**ANOTHER PREVIEW OF CRACKS & FUNGUS DEVELOPED ON EXTERNAL DEADWALLS**

**6.6.** Many cracks were noticed at external surface. Hence it is recommended that all existing cracks have to be properly grooved in "V" shape and accordingly to be refilled with waterproofing based crack filler.

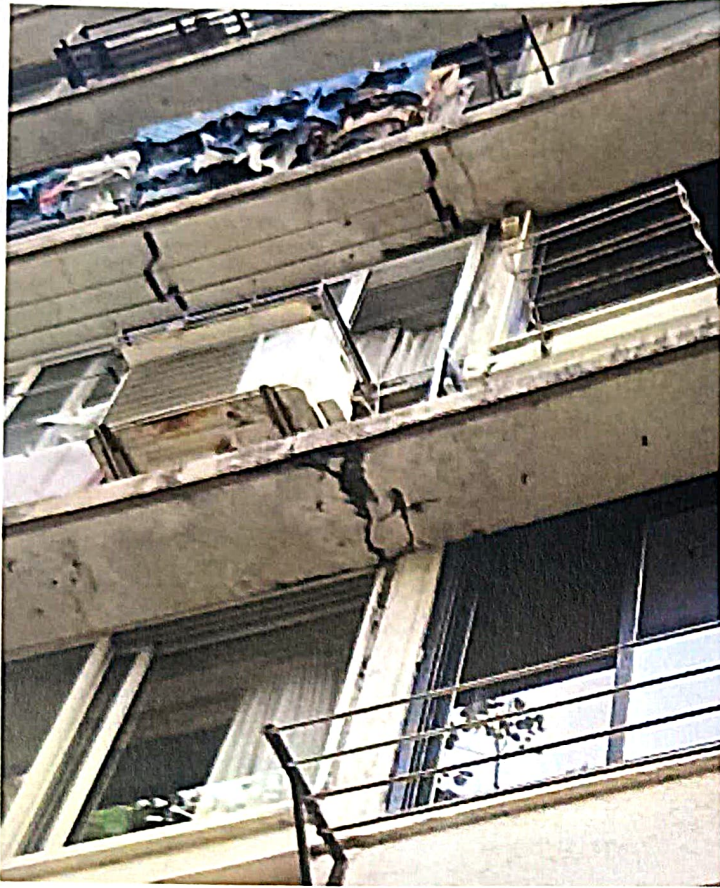
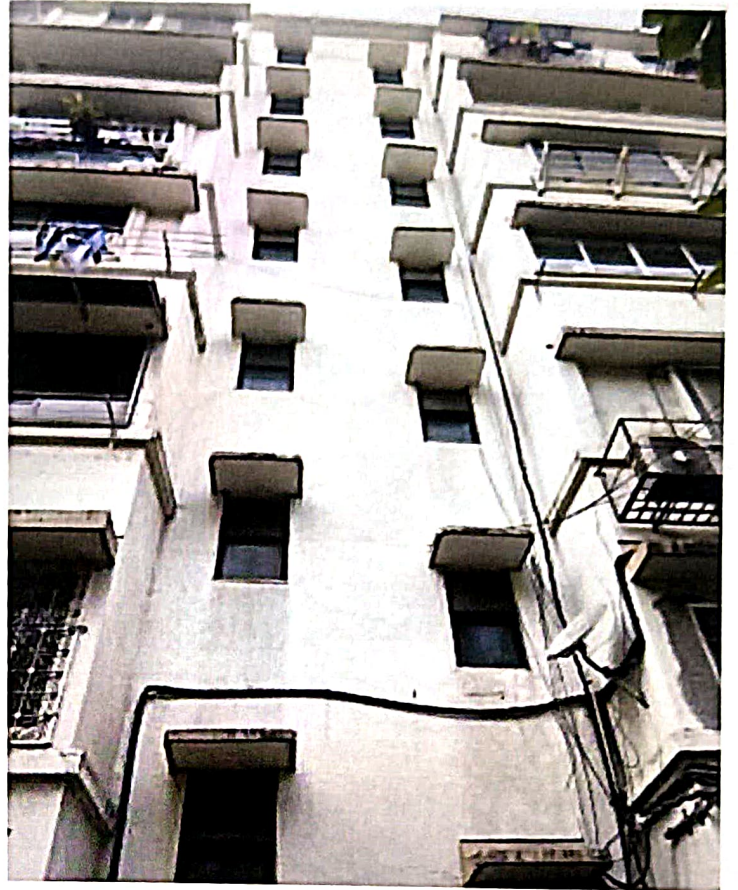
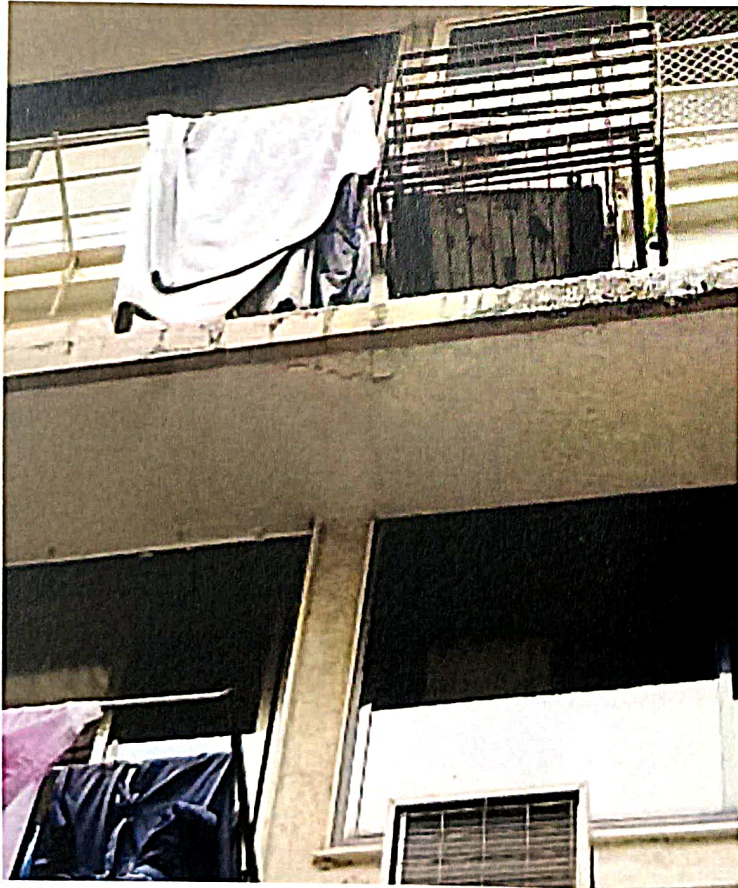
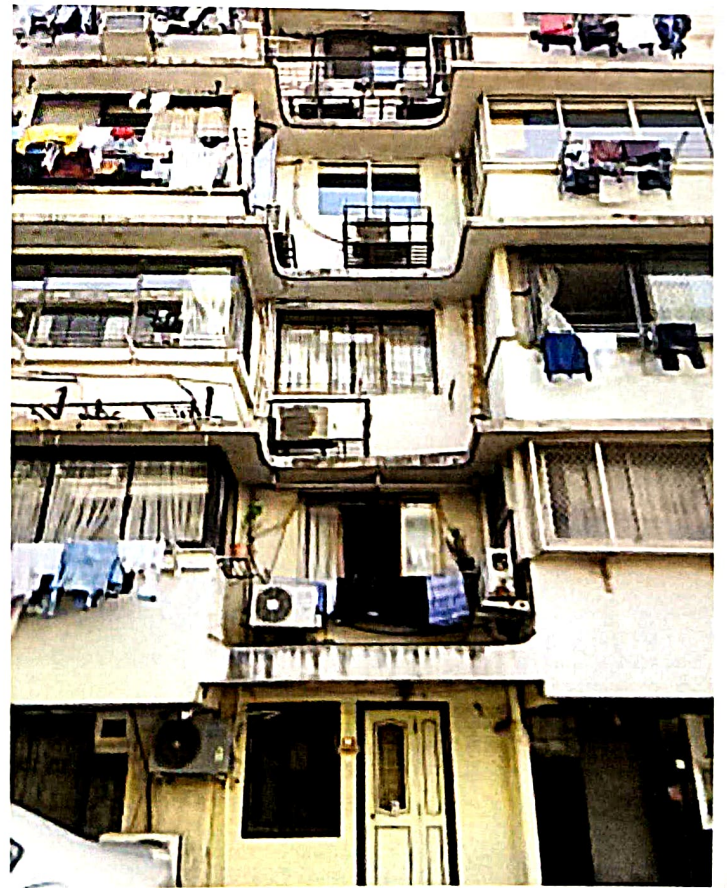
**Noticed Chajja found highly damaged condition**

**6.9.** Some of the chhajjas are found insufficient watta at few locations. Damaged chhajjas need to be treated by Polymer Modified Mortar method & finally it should be plastered from bottom and to be waterproofed by brickbat coba method from top if required. Sufficient watta are also needed to be prepared simultaneously. The same process can be applied for over head room & balcony waterproofing. Highly damaged chhajjas / pardis needs to be recast with RCC to bring to its original condition.

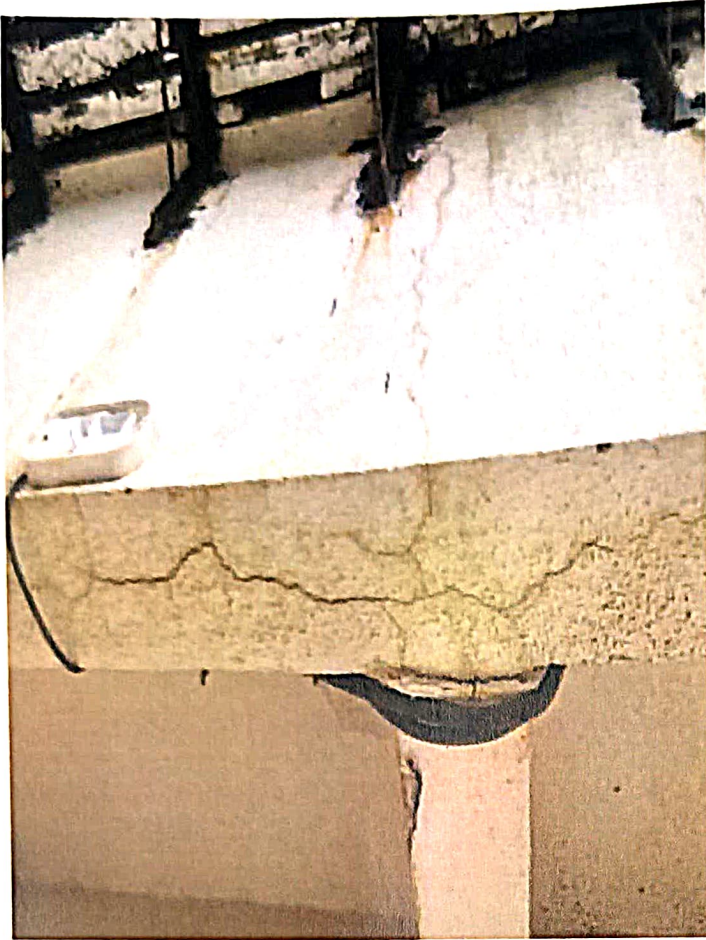
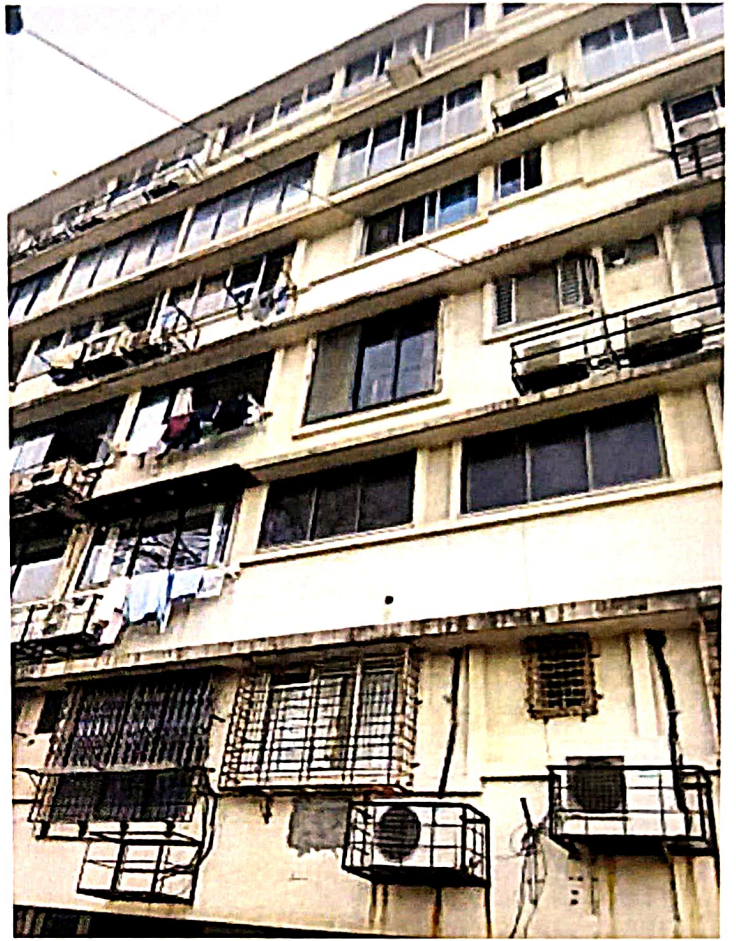
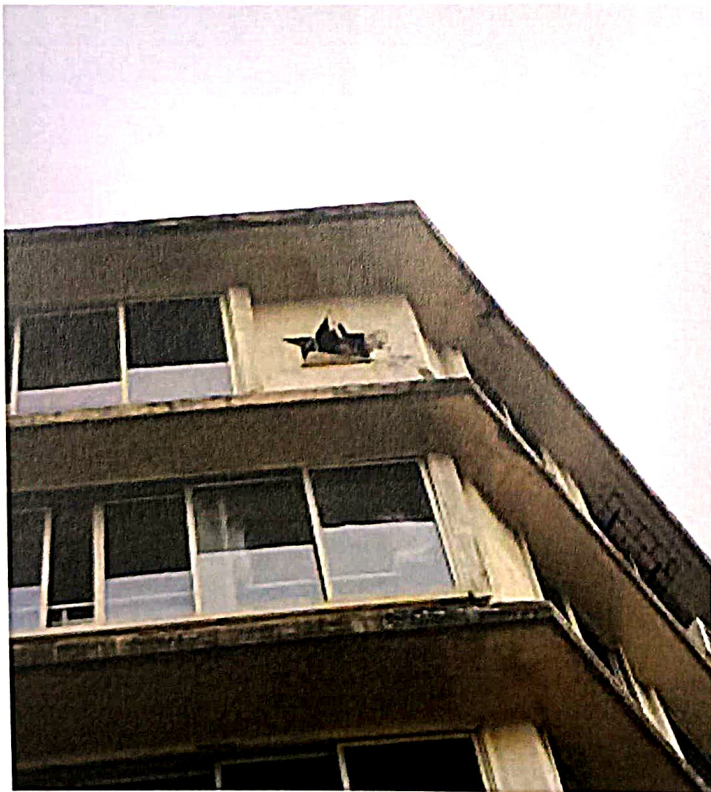
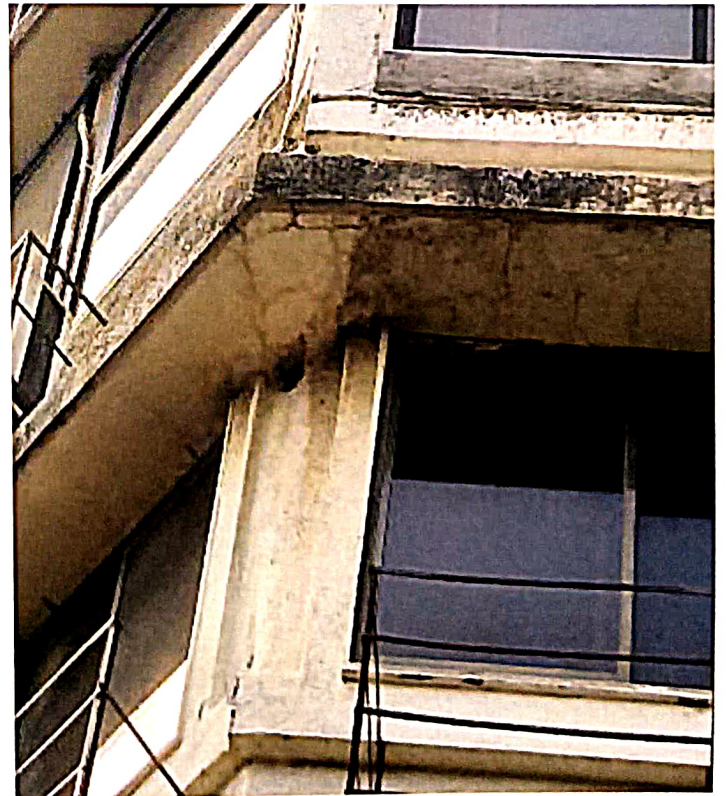
**Noticed plaster damages at External wall of the building**

**6.3.** As the existing External plaster has failed due to delamination, crazing and cracks at certain places and hence Patch plaster is required to the affected area of the building wherever necessary. Over Head Tank and Staircase room cabin, parapet wall, Pump room, etc. are also to be treated externally through two coat plaster wherever necessary

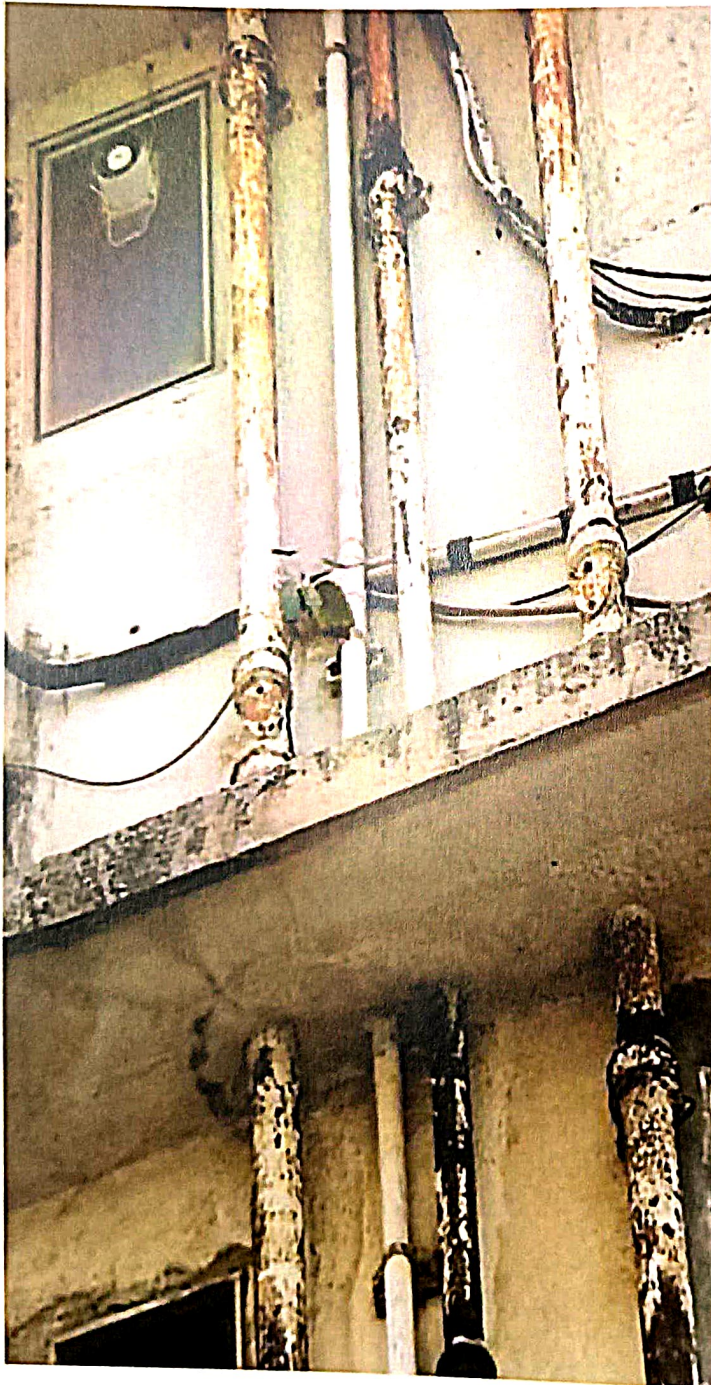
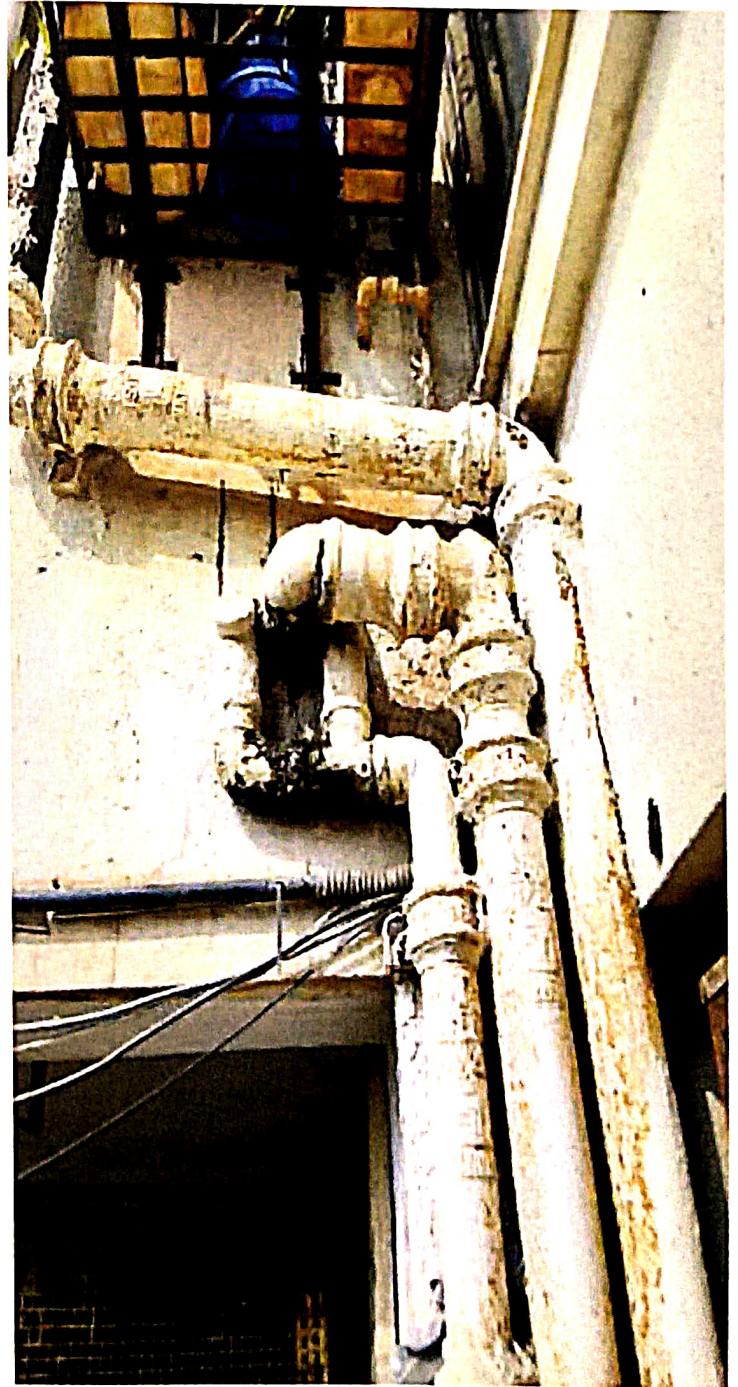
**NOTICED MAJOR LEAKAGES NEAR DRAINAGE PIPES.**

**6.5.** Plumbing lines have got leakage at many places especially at joints. So existing old damaged pipes or fittings needs to be changed to new PVC pipes with fittings at identified location. Special bracket clamps can be provided to hold all pipes away from external wall wherever necessary.

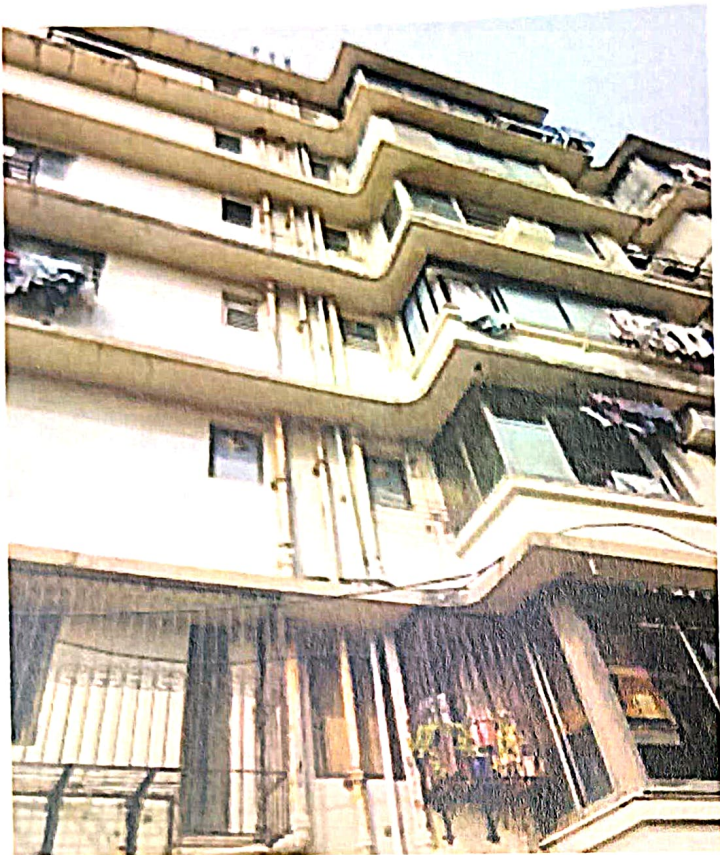
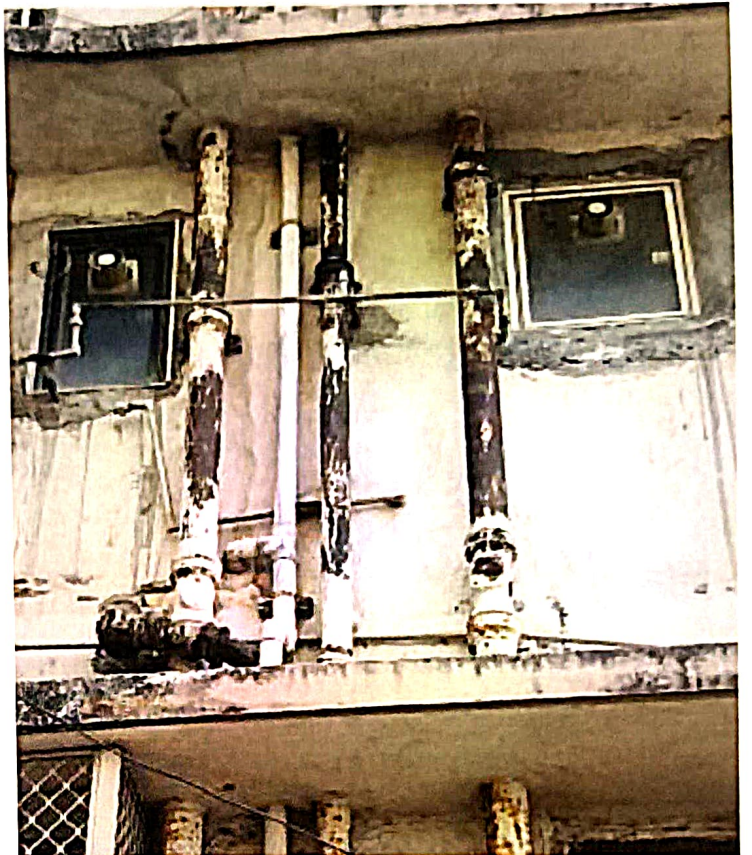
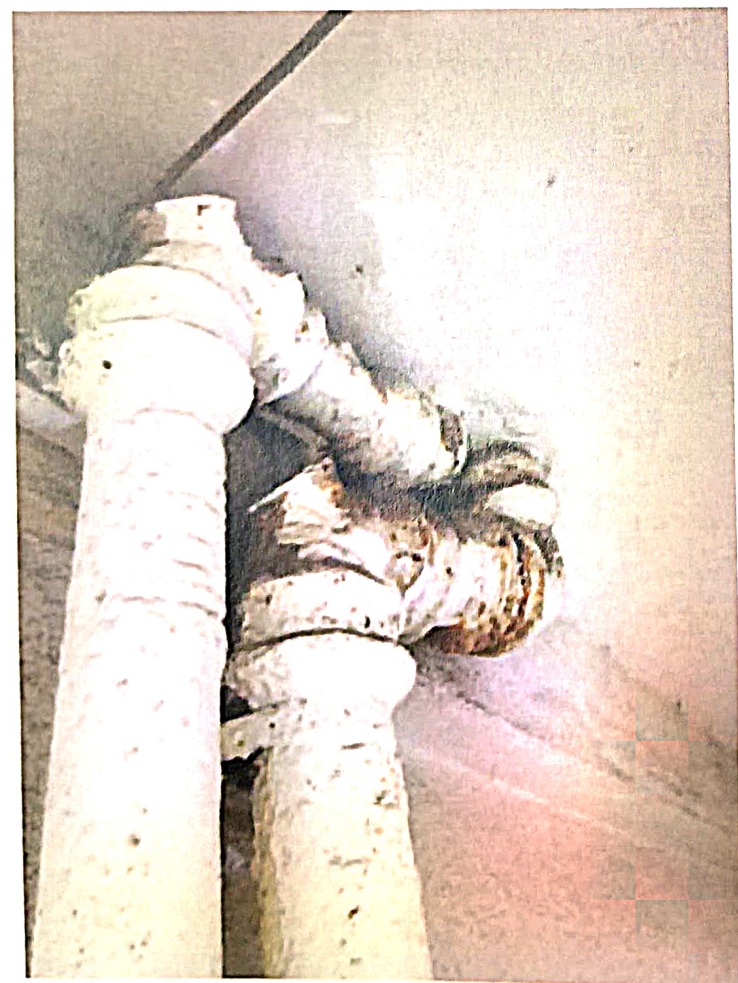
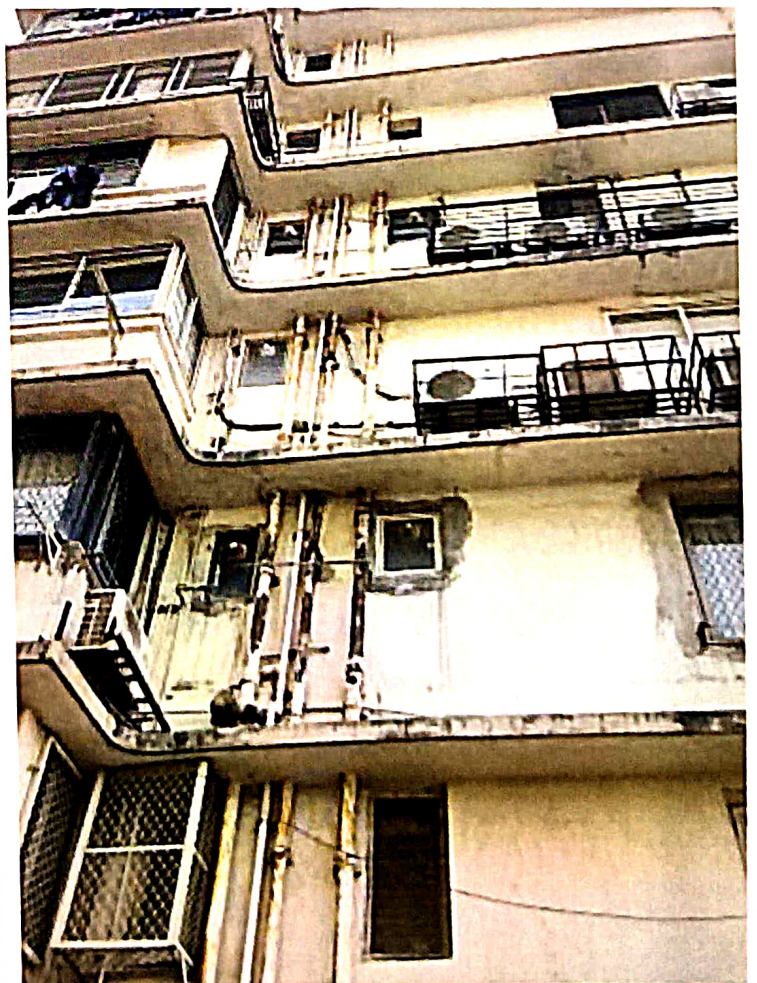
**NOTICED LEAKAGES NEAR PIPES AND PLASTER DAMAGE**

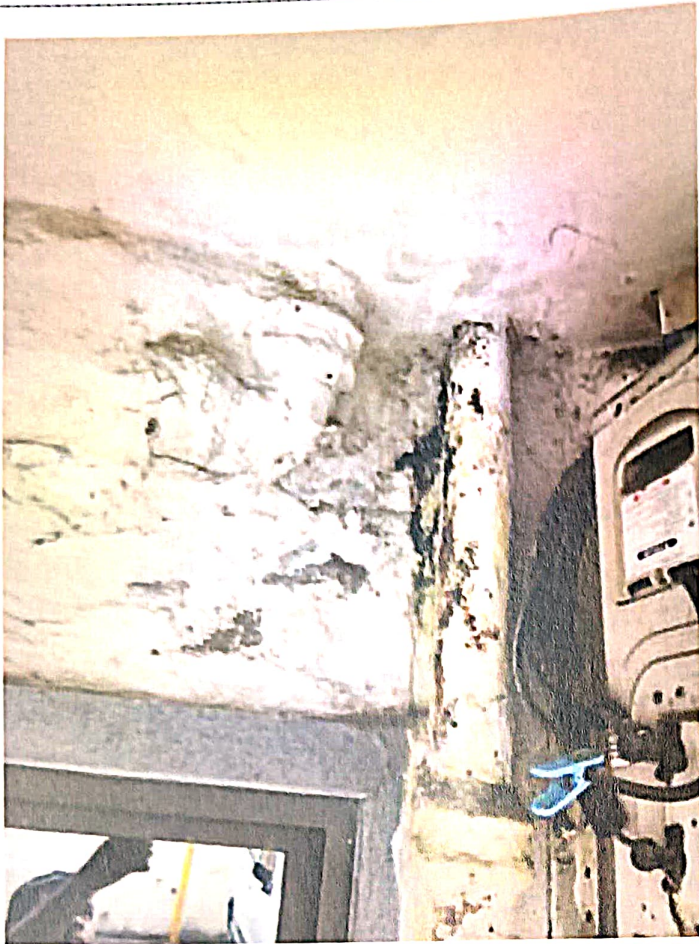
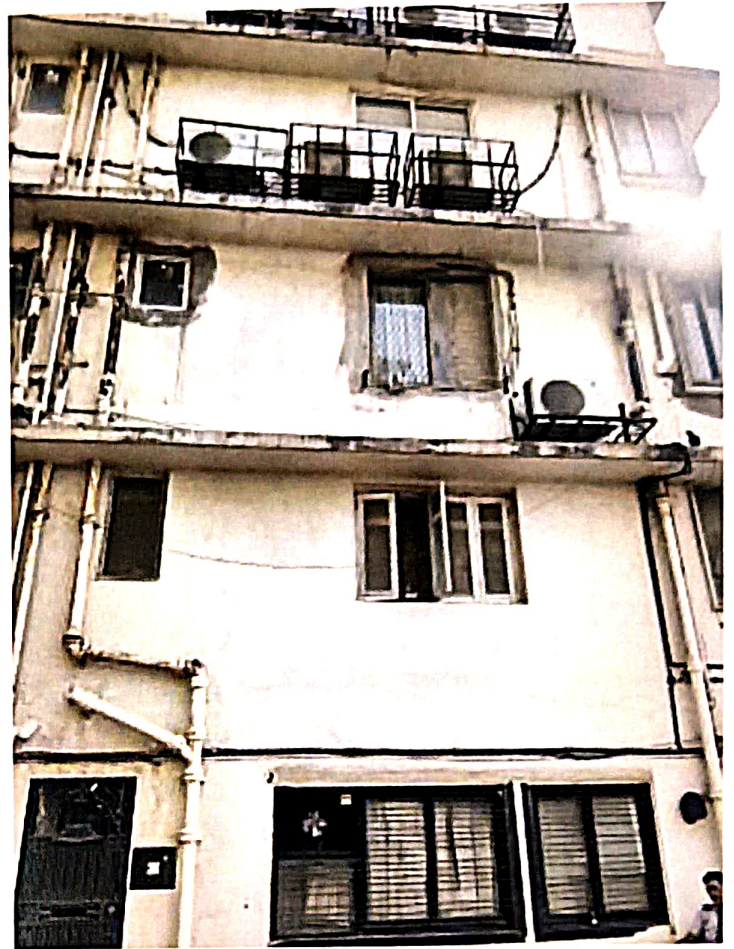
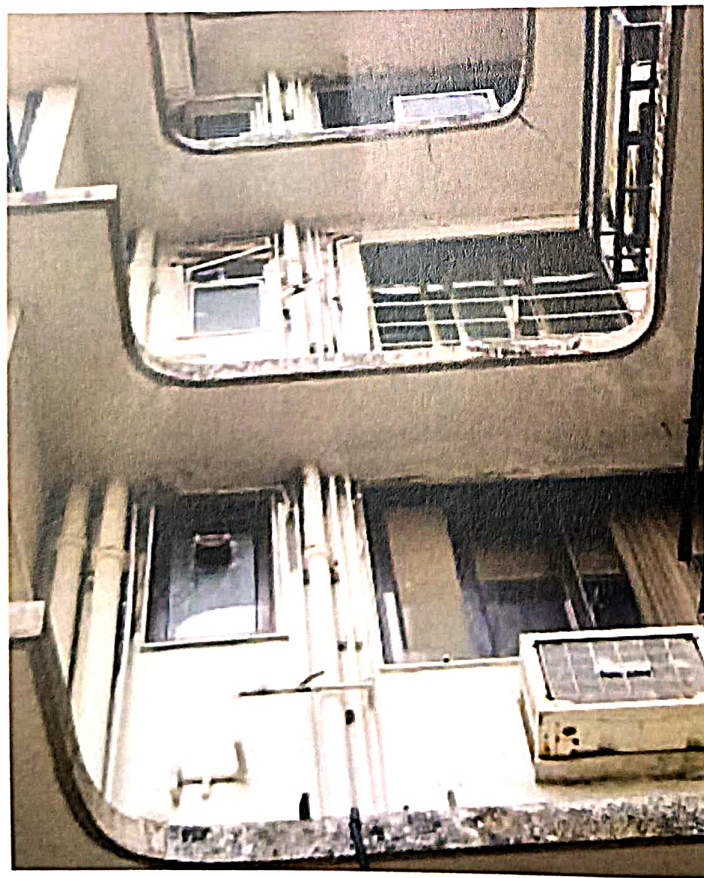
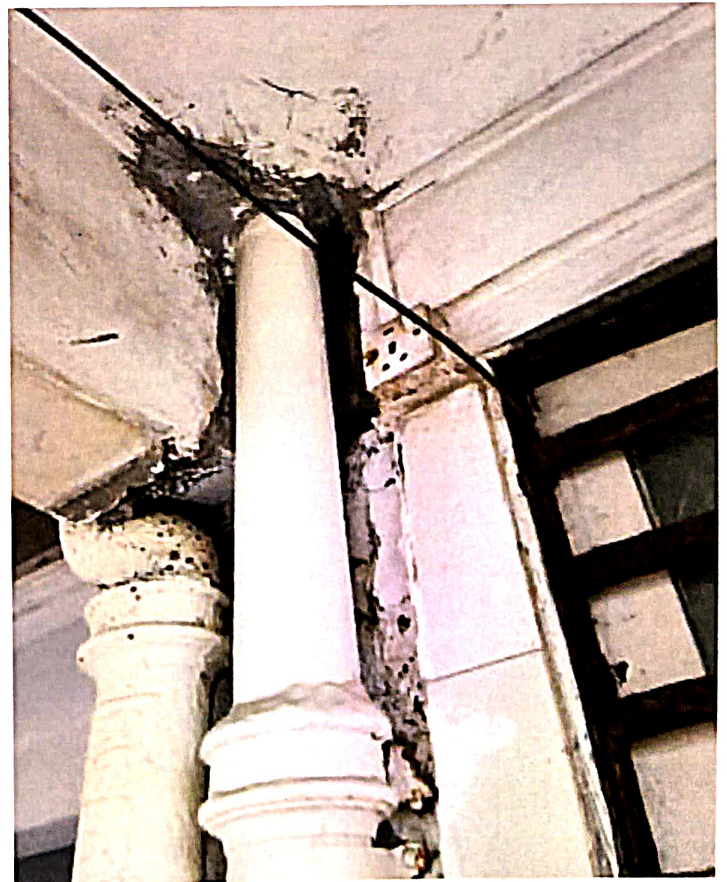
**NOTICED LEAKAGES NEAR PIPES AND PLASTER DAMAGE**

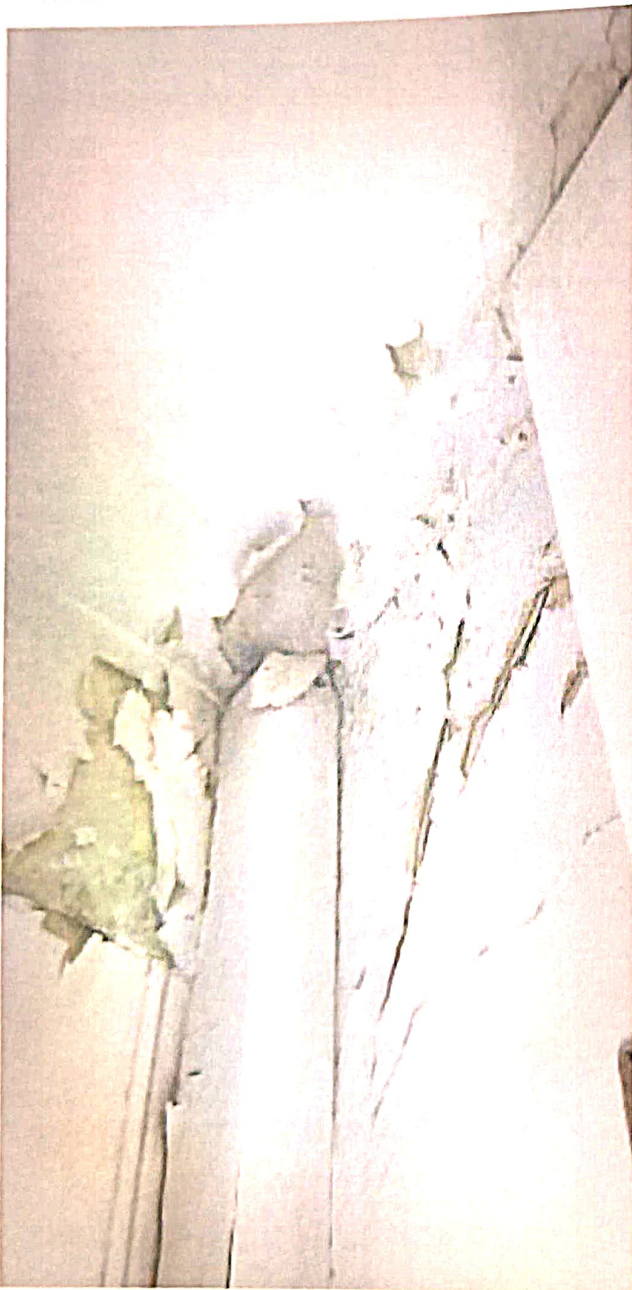
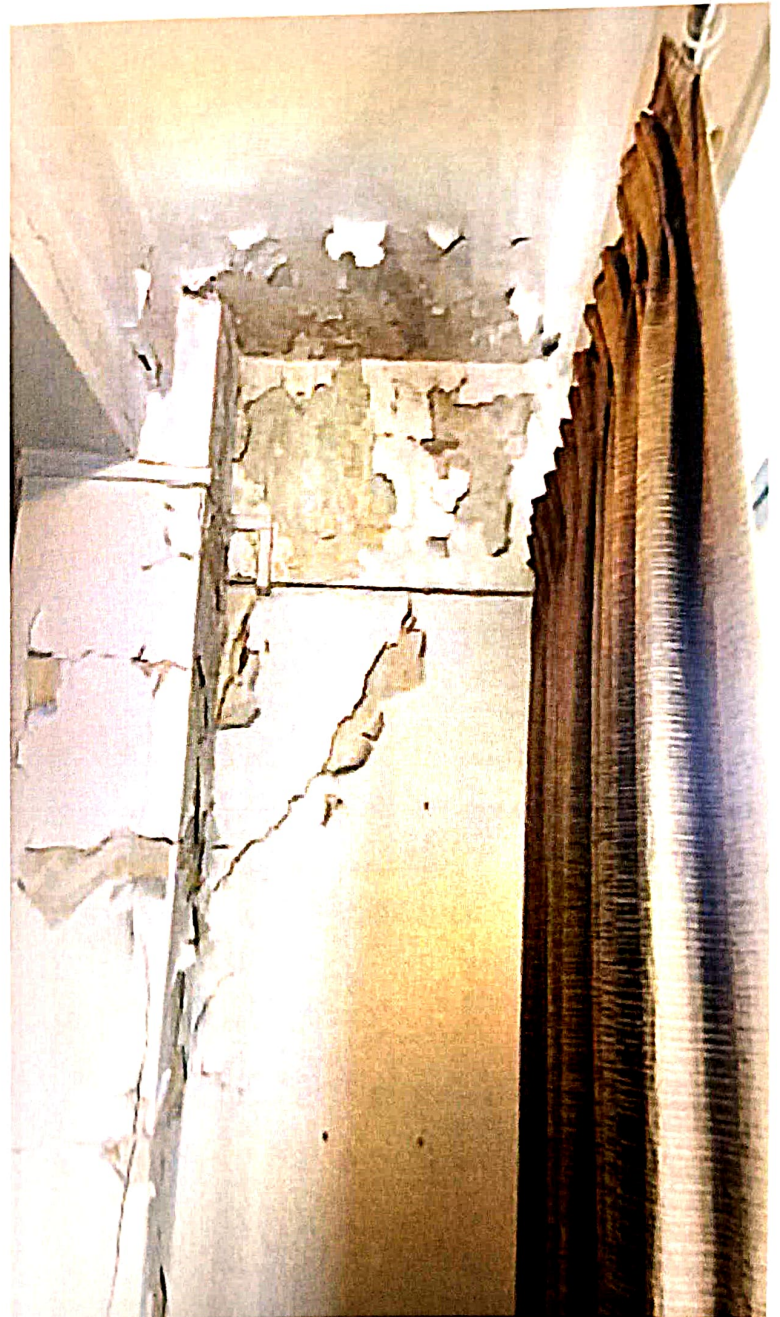
**NOTICED LEAKAGE IN CEILING AT BEDROOM AREA**

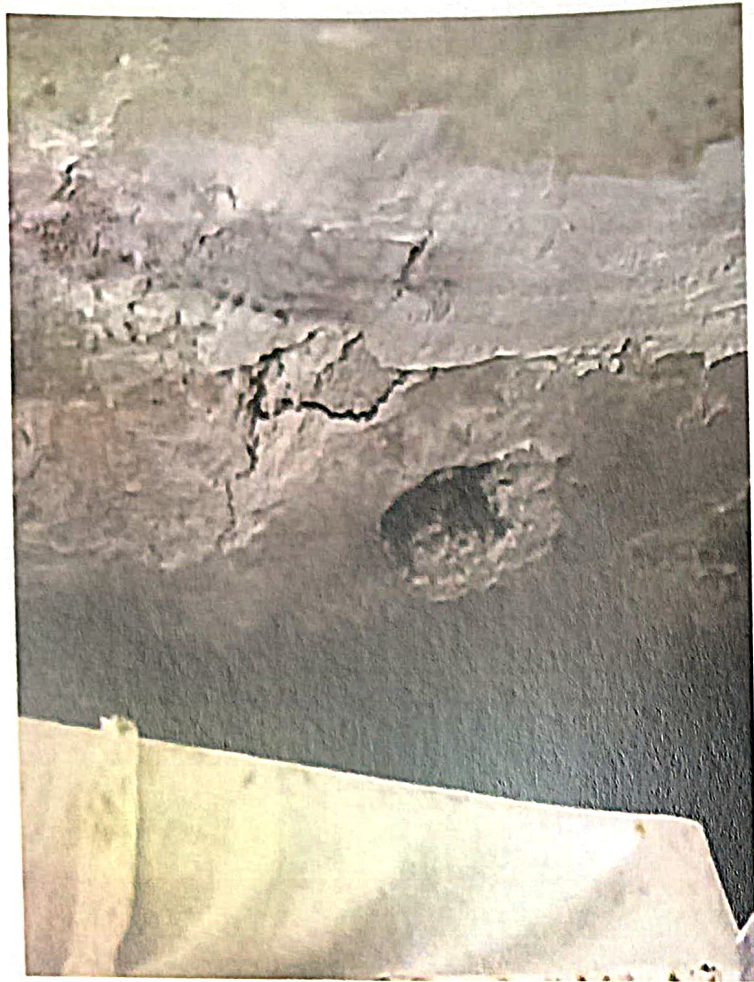
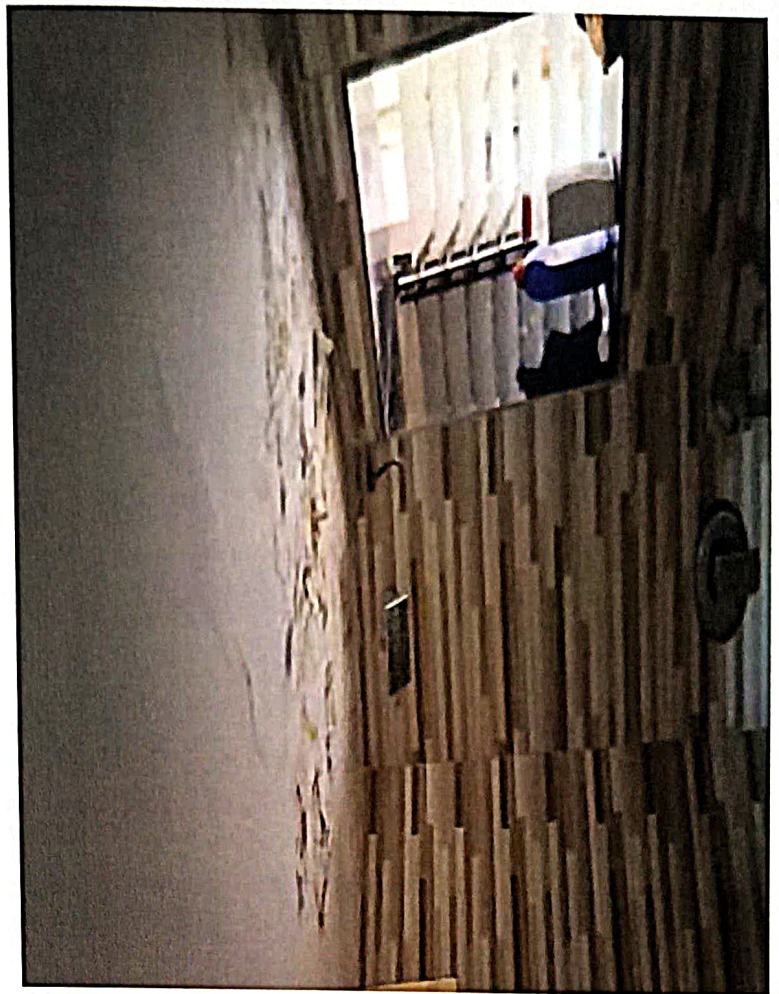
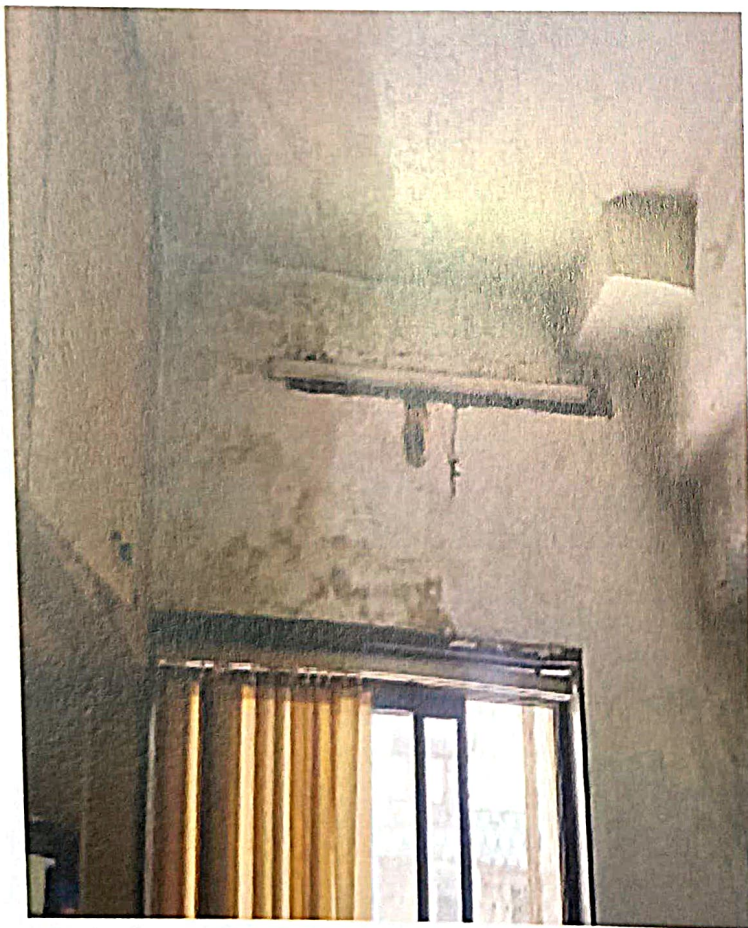
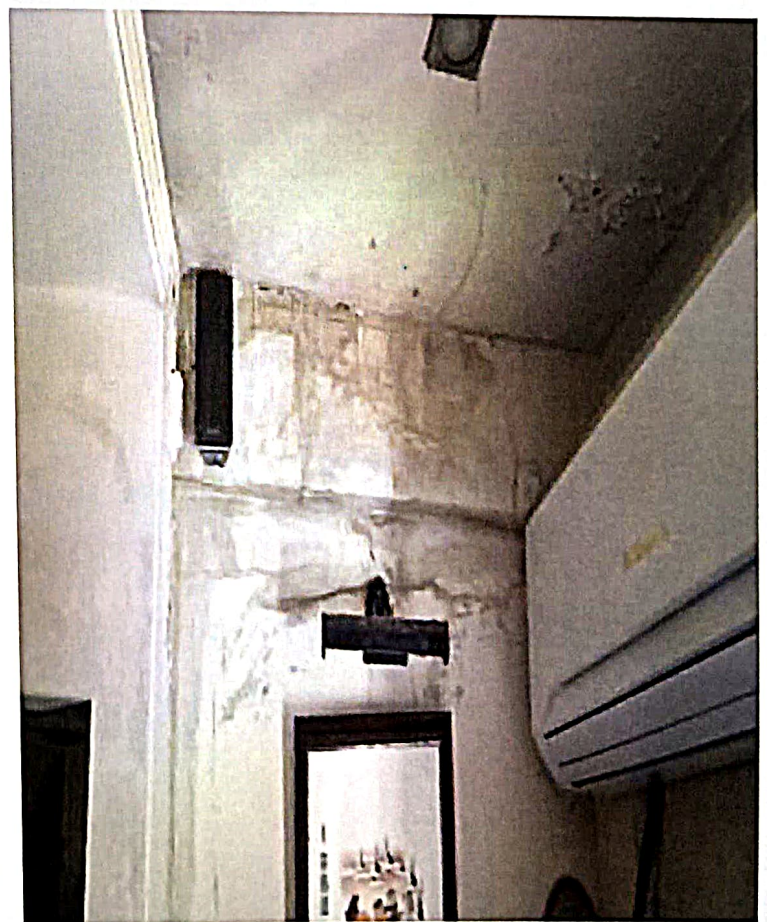
**NOTICED BEDROOM CEILING LEAKAGE**

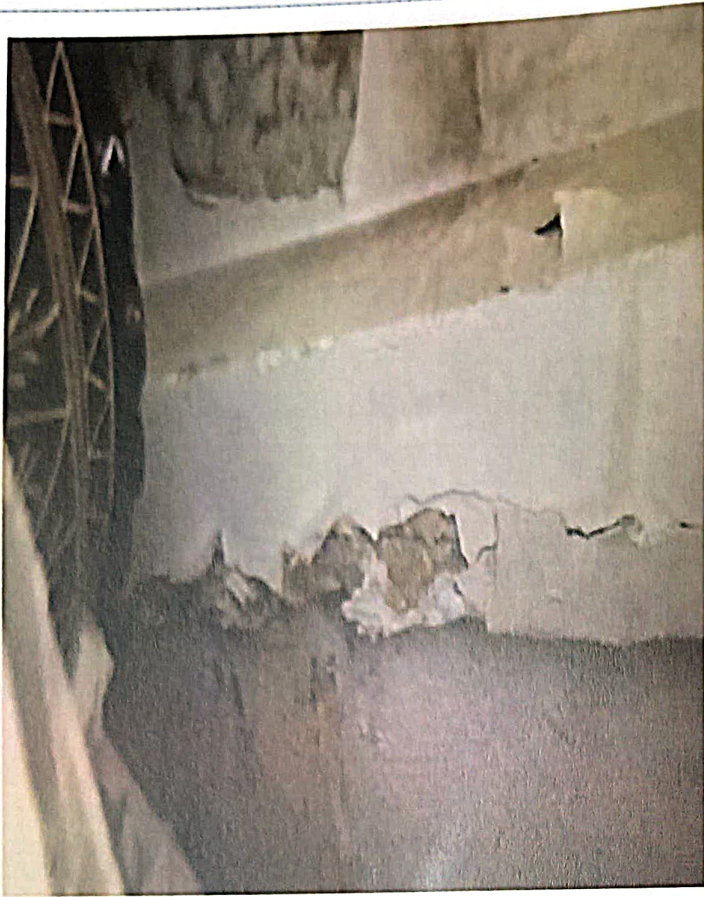
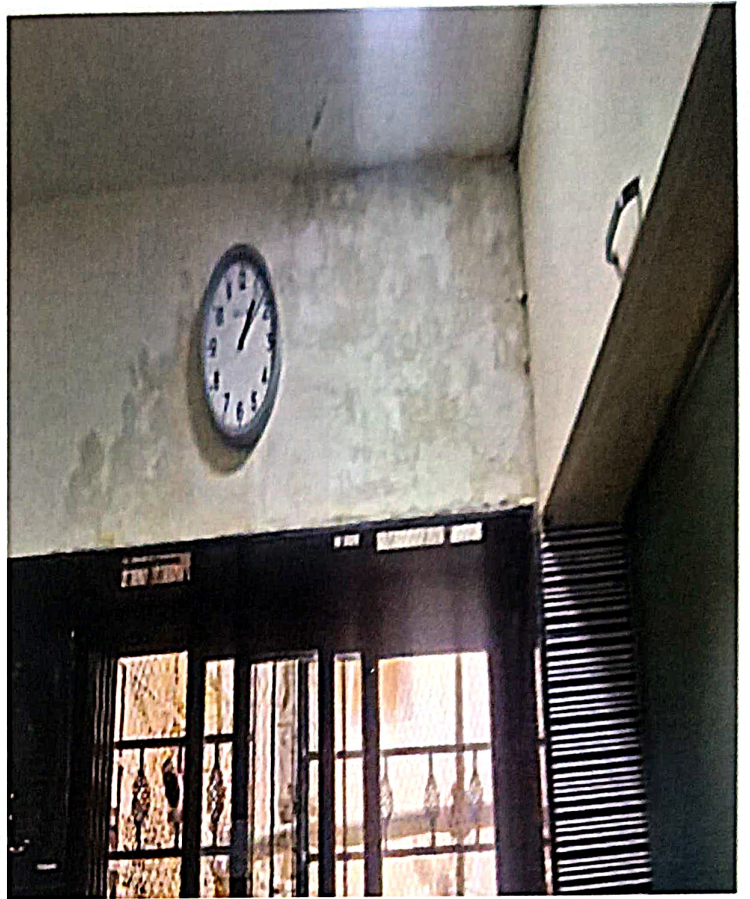
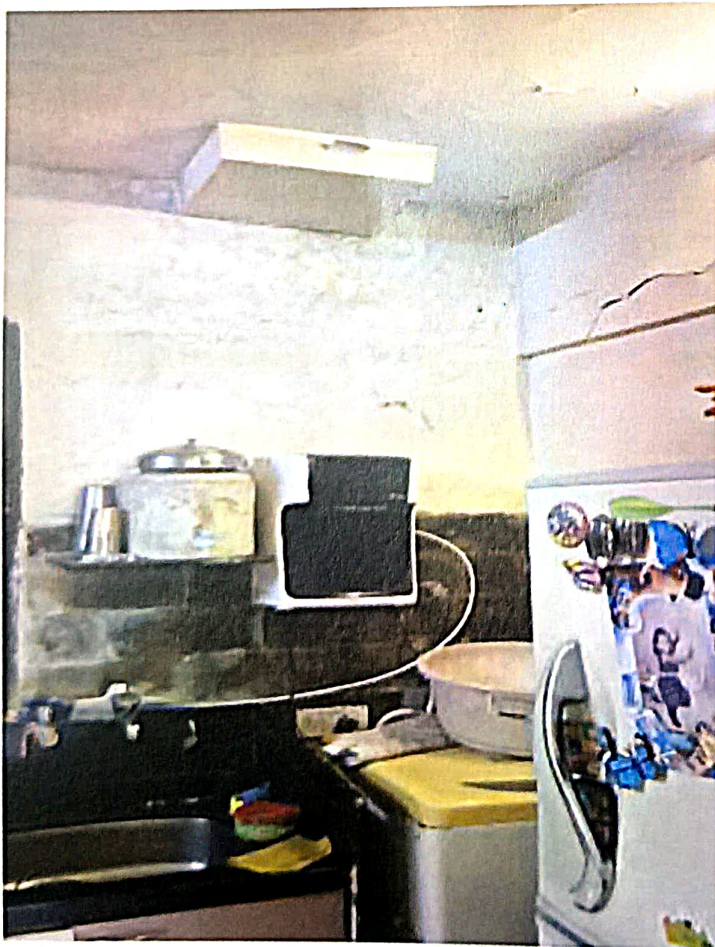
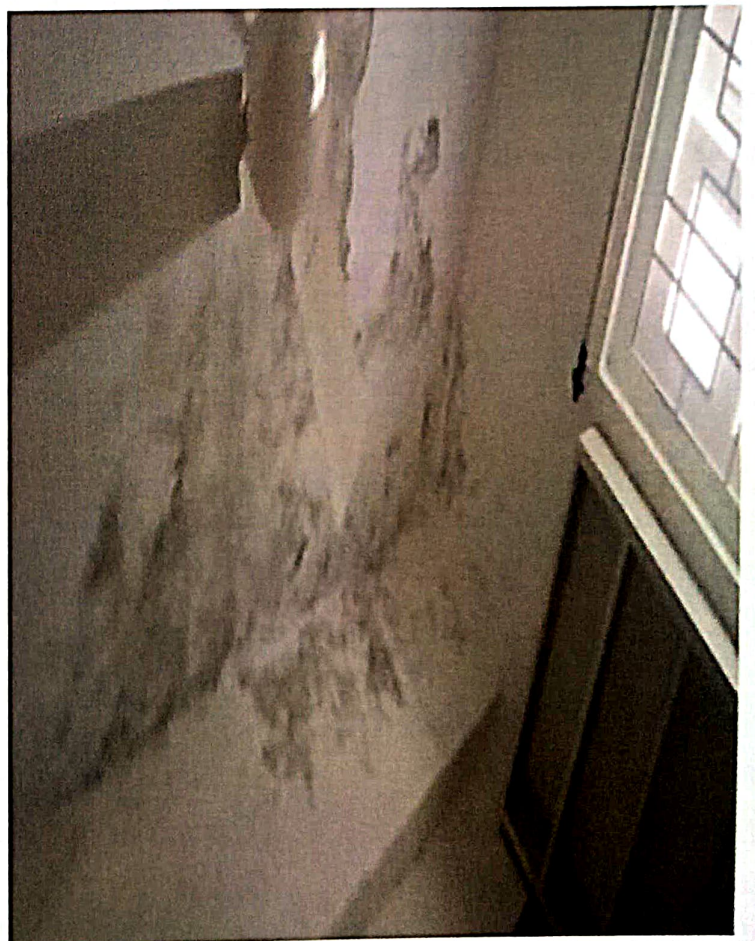
**NOTICED KITCHEN CEILING LEAKAGE**
