SUB: SUBMISSION OF STRUCTURAL AUDIT / SURVEY REPORT OF SIMLA HOUSE CHS LTD.

**STATUTORY STRUCTURAL AUDIT REPORT  
OF**

**SIMLA HOUSE CO-OPERATIVE HOUSING SOCIETY LTD.**

**51/B, NEPEAN SEA ROAD, MALABAR HILL, MUMBAI-400026**

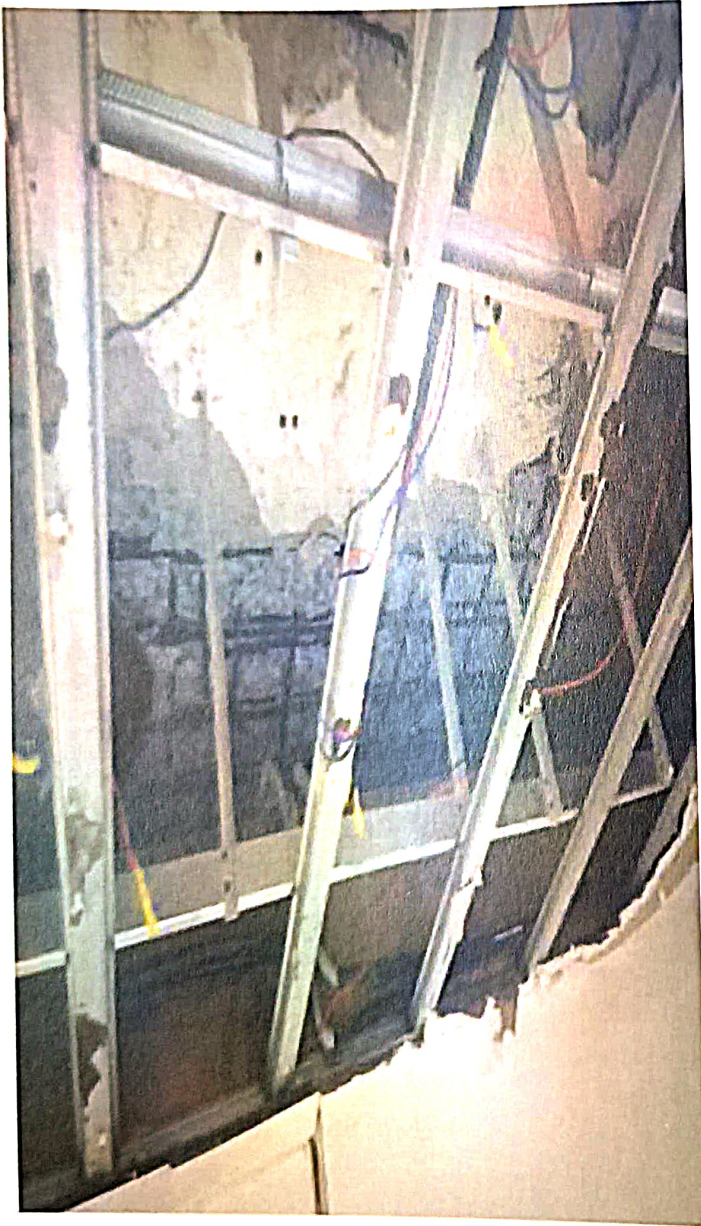
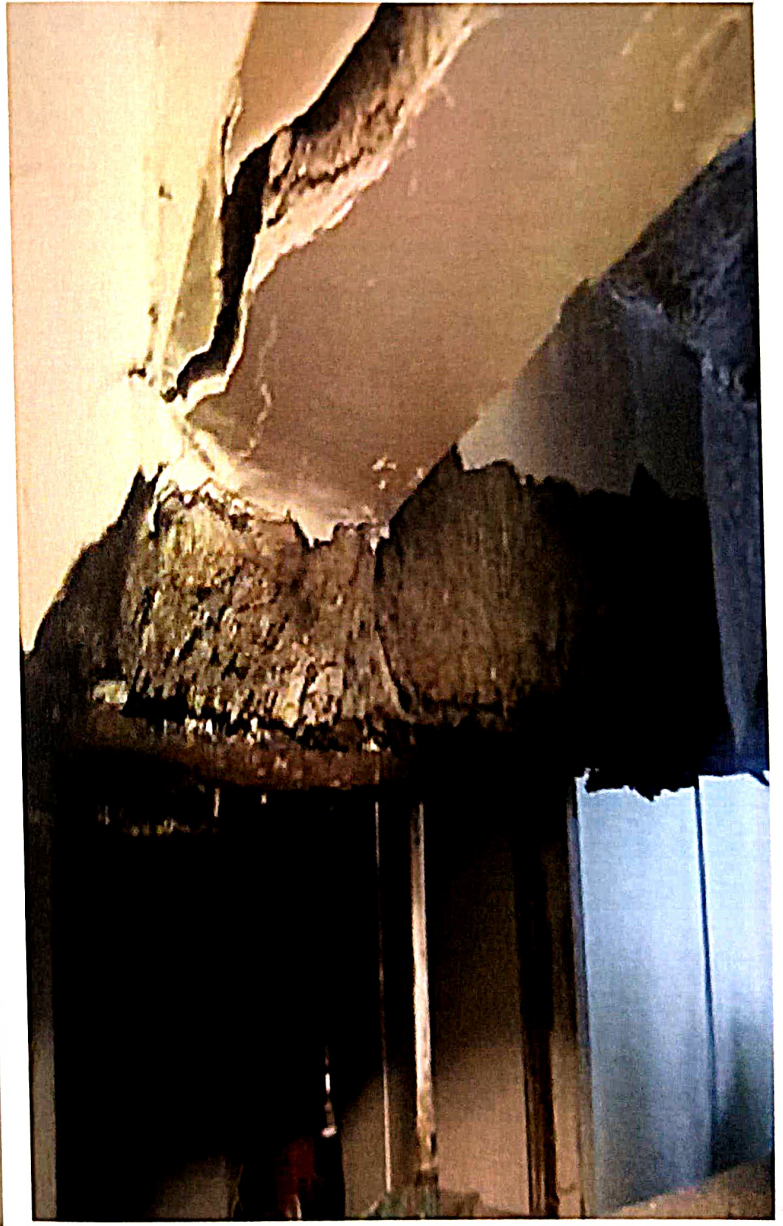
**MAJOR COLUMN DAMAGED HAS BEEN OBSERVED INSIDE THE FLAT**

**6.2.** Highly damaged RCC members such as columns, beams, slabs, chajjas, pardis, etc. shall be treated with Recasting or High performance Micro concrete after proper shuttering and fitting reinforcements.

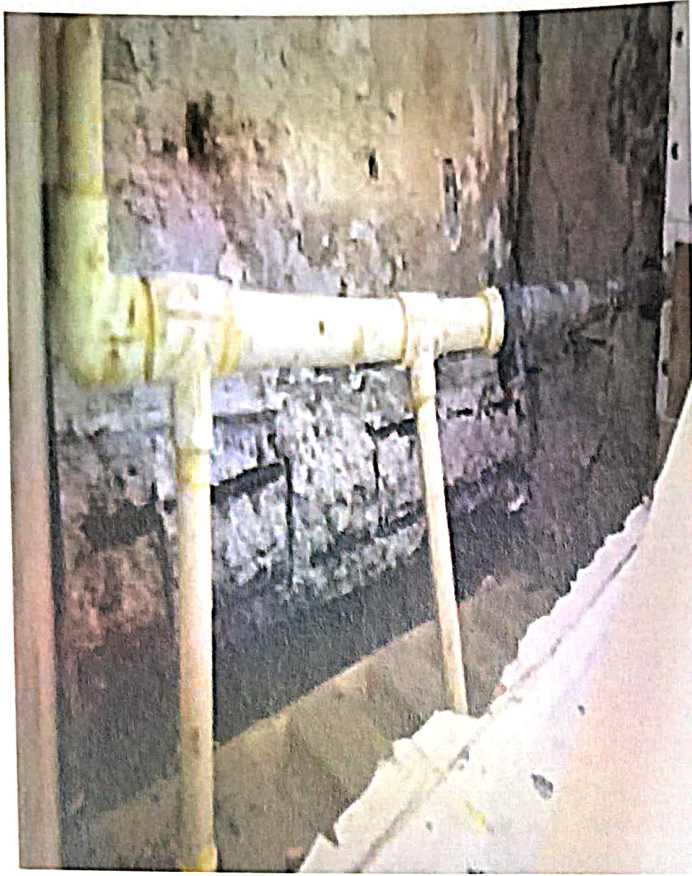
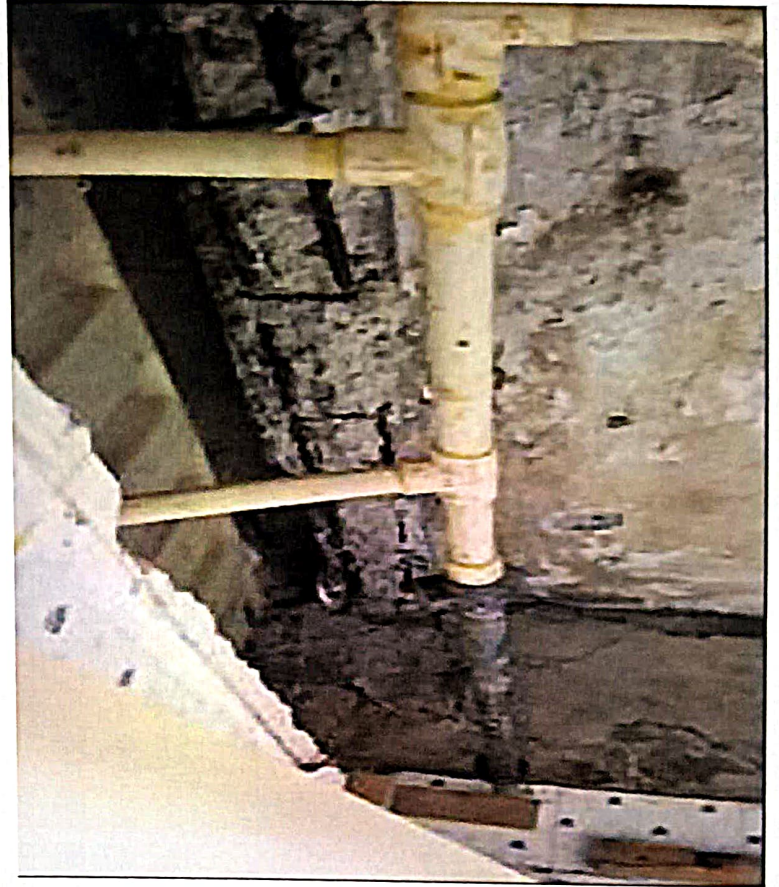
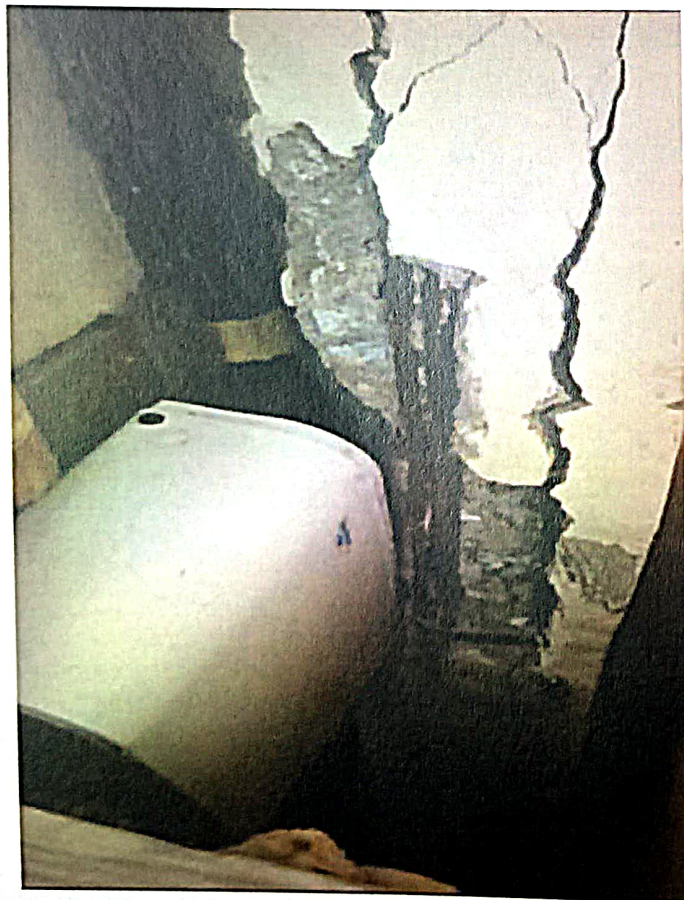
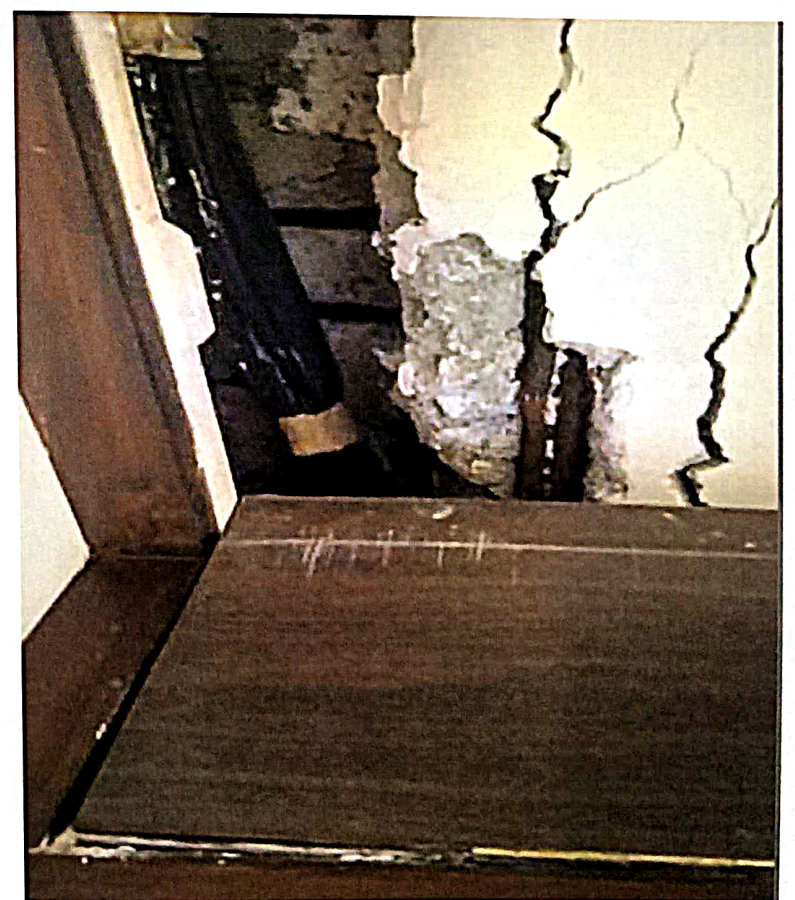
**MAJOR COLUMN DAMAGED HAS BEEN OBSERVED AT INSIDE FLAT**

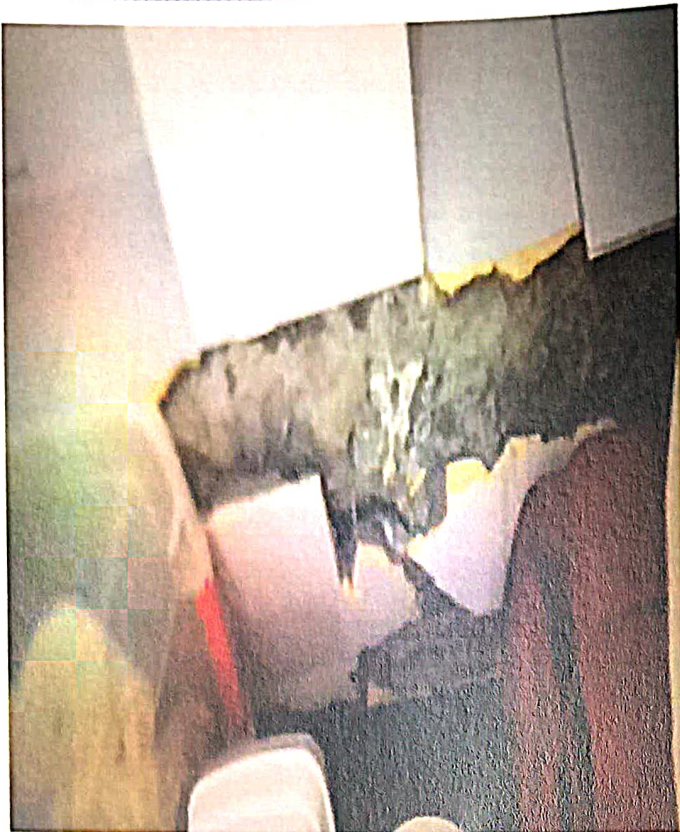
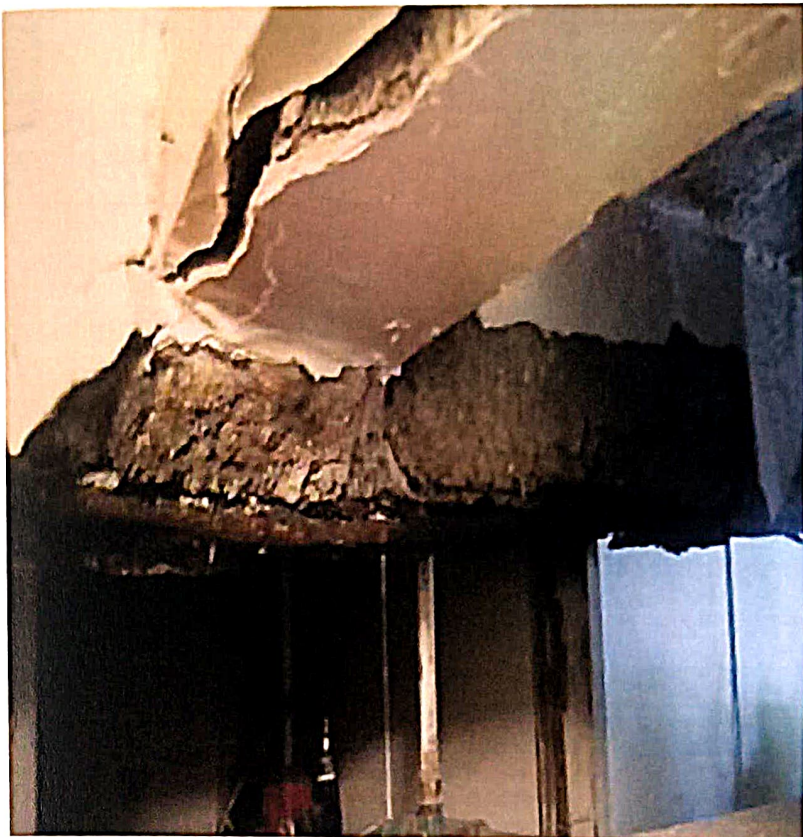
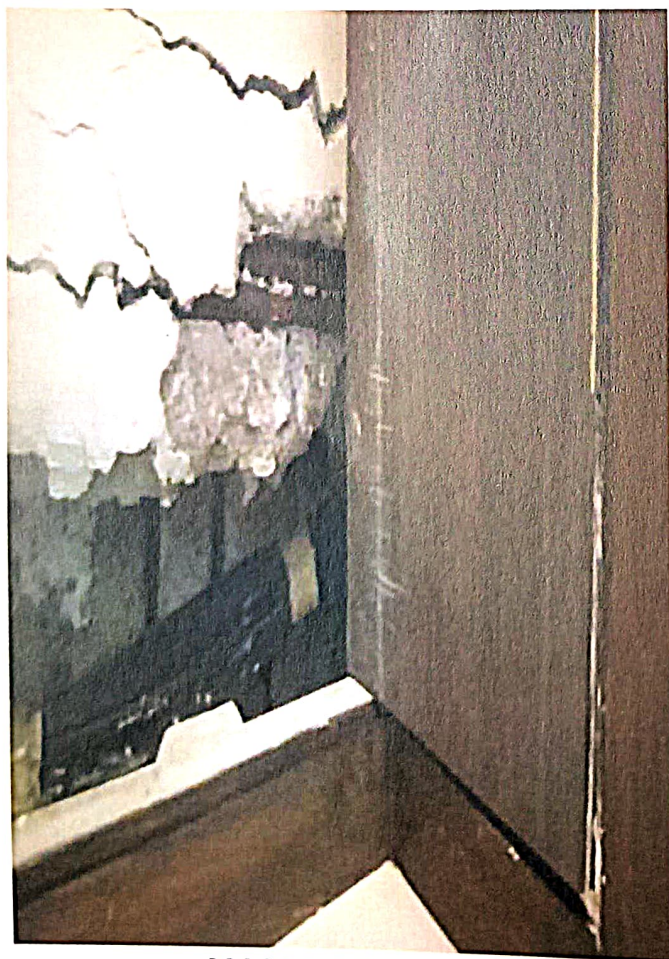
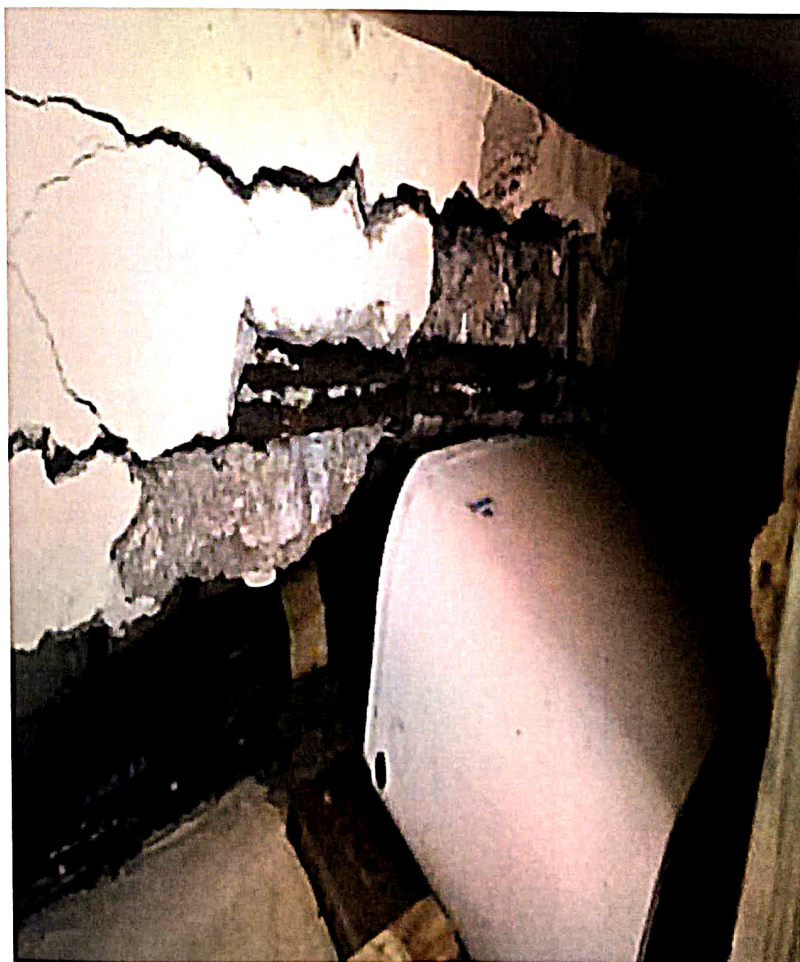
**MAJOR COLUMN DAMAGED HAS BEEN OBSERVED INSIDE FLAT**

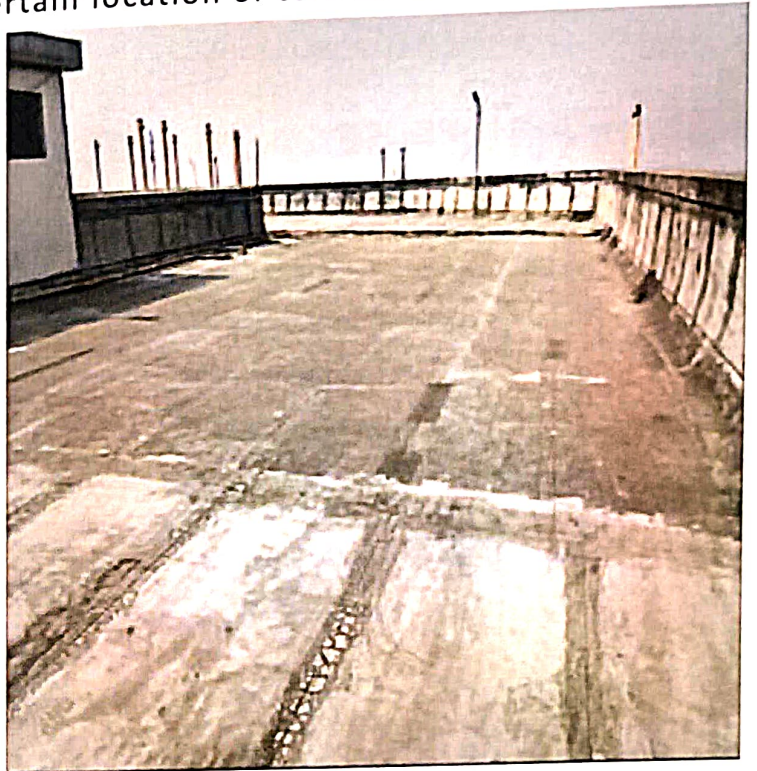
**TERRACE FLOOR AREA DEVELOPED AIR POCKETS AT MANY PLACES**

**6.8.** Water proofing over terrace is found in bad condition. However based on actual observation from inside flats, it is the need of hour to retrofit the entire terrace chemical coating waterproofing system.

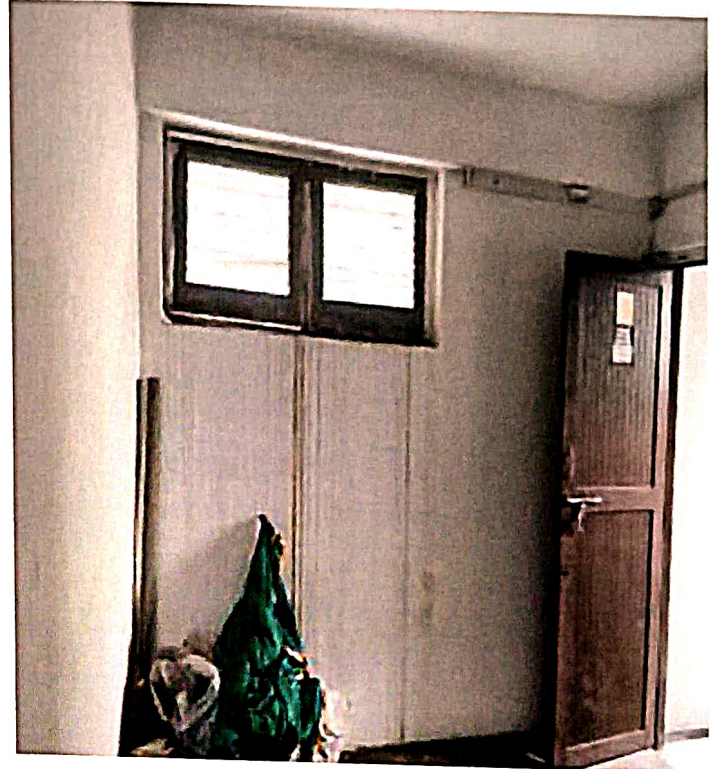
**LEAKAGES NOTICED IN THE LIFT ROOM AREA**

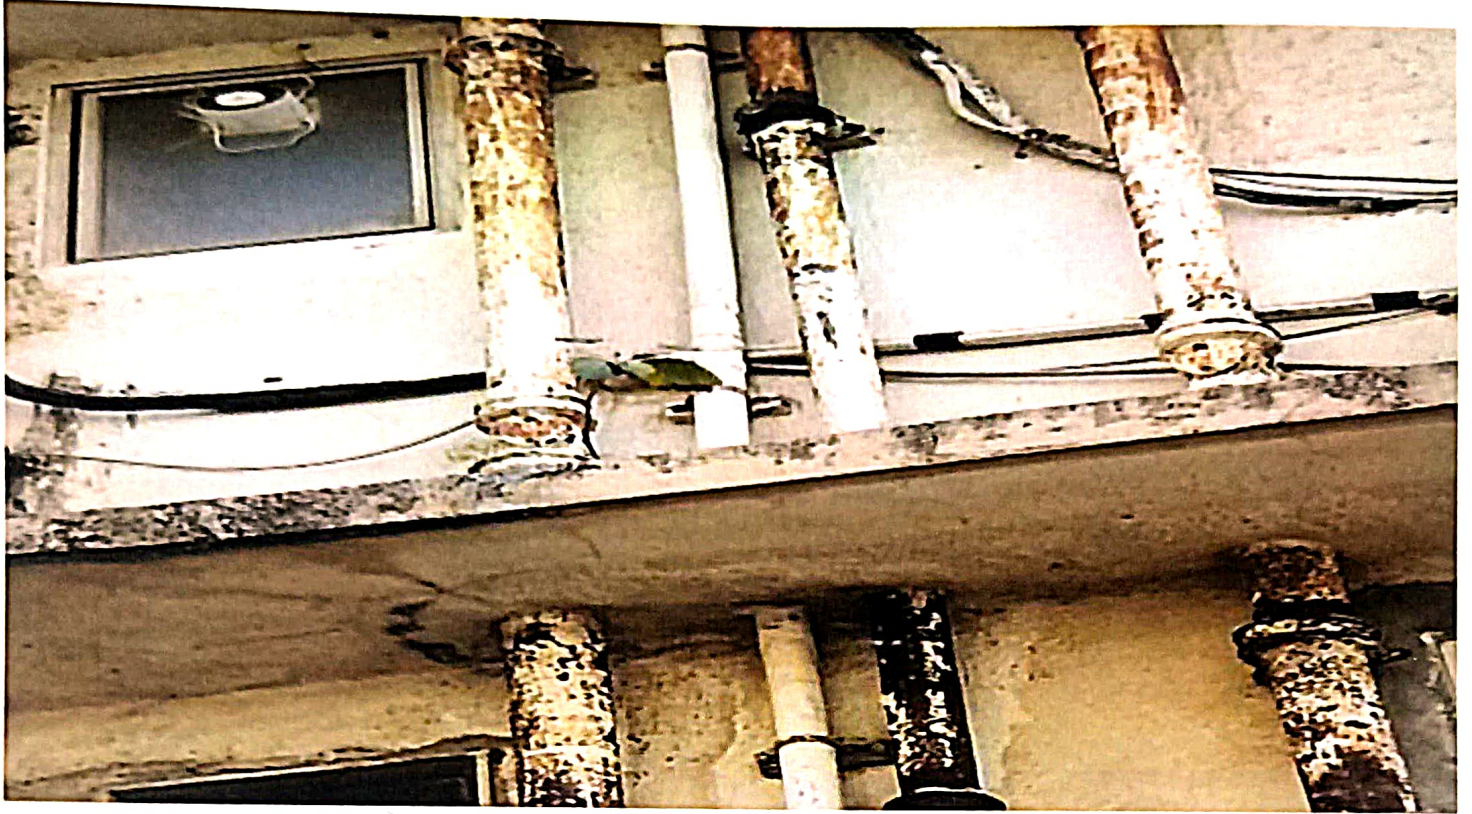
1. NOTICED VEGETATION GROWTH DEVELOPED AT EXTERNAL WALL AREA

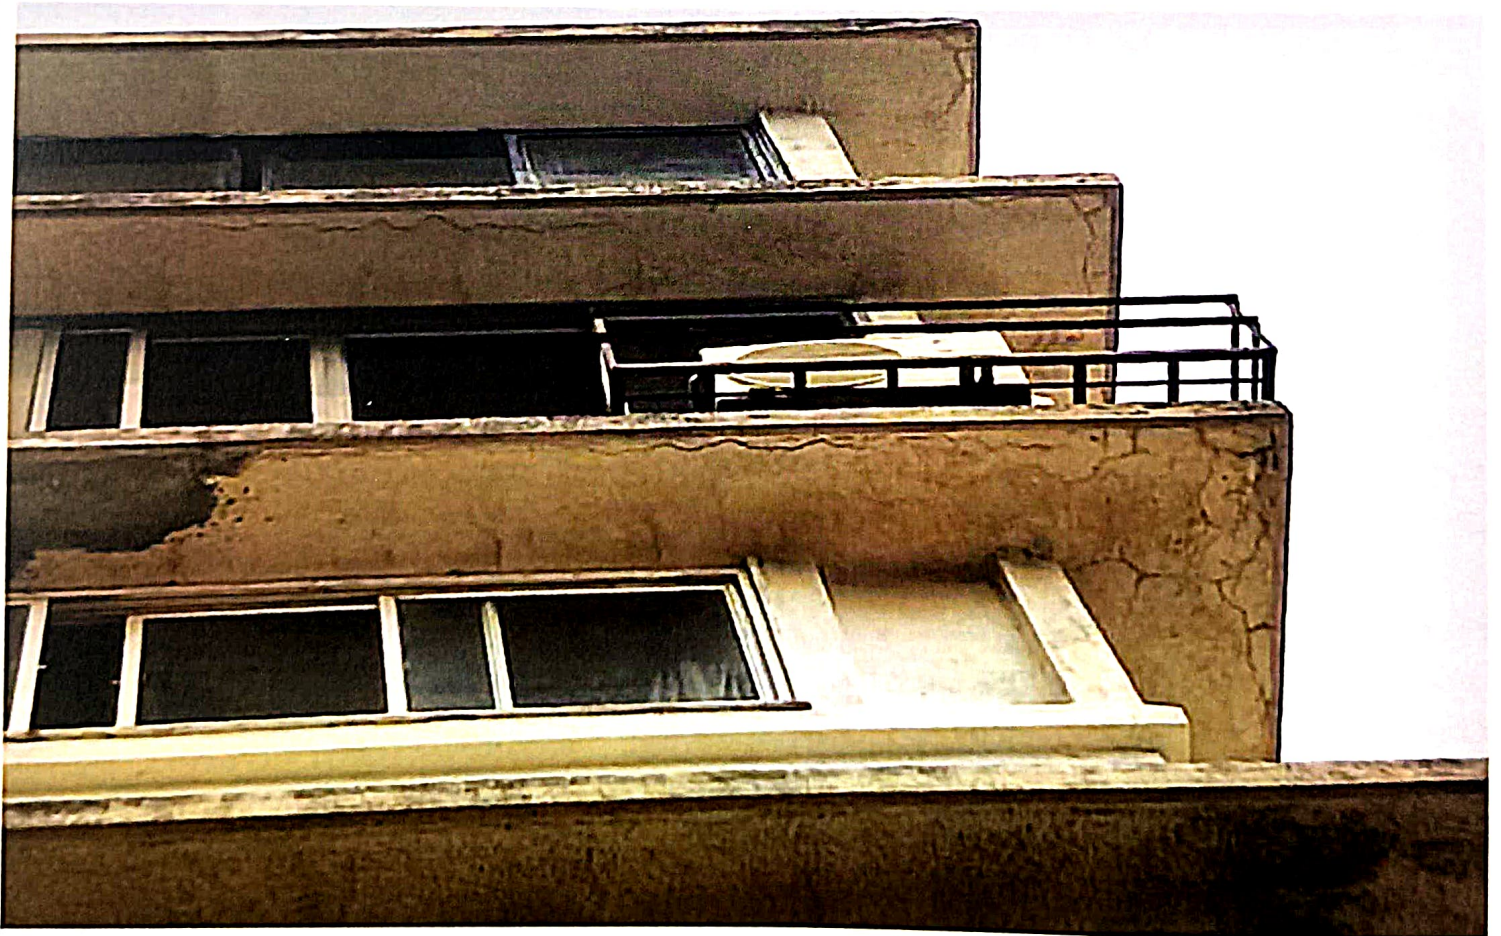
2. EXTENSIVE CRACK & FUNGUS OBSERVED ON THE EXTERNAL WALL PLASTER

**6.6.** Many cracks were noticed at external surface. Hence it is recommended that all existing cracks have to be properly grooved in "V" shape and accordingly to be refilled with waterproofing based crack filler.

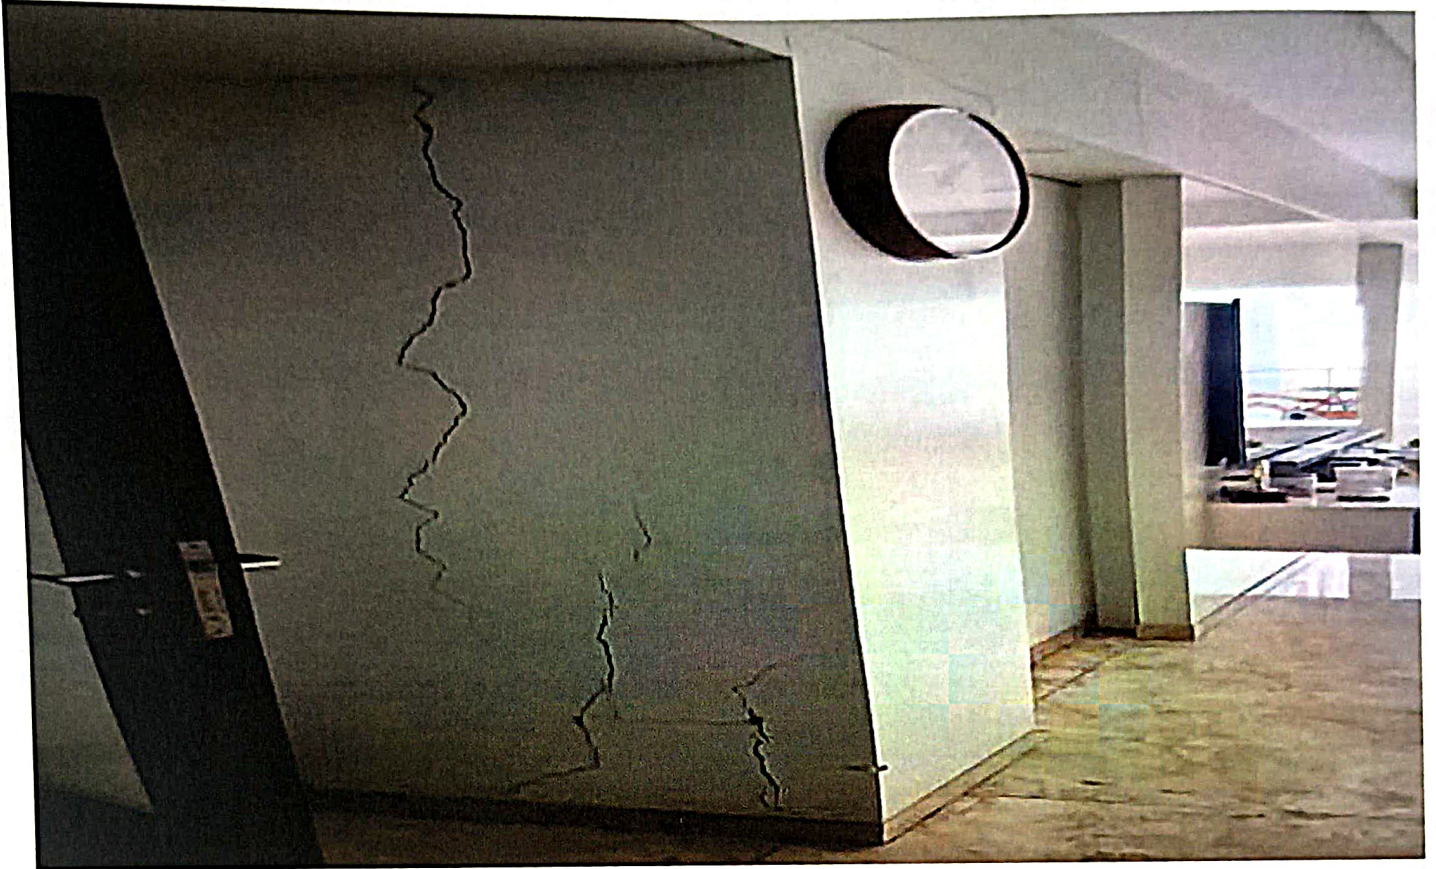
**3. DAMAGES IN COLUMN HAS BEEN OBSERVED IN INTERNAL SIDE**

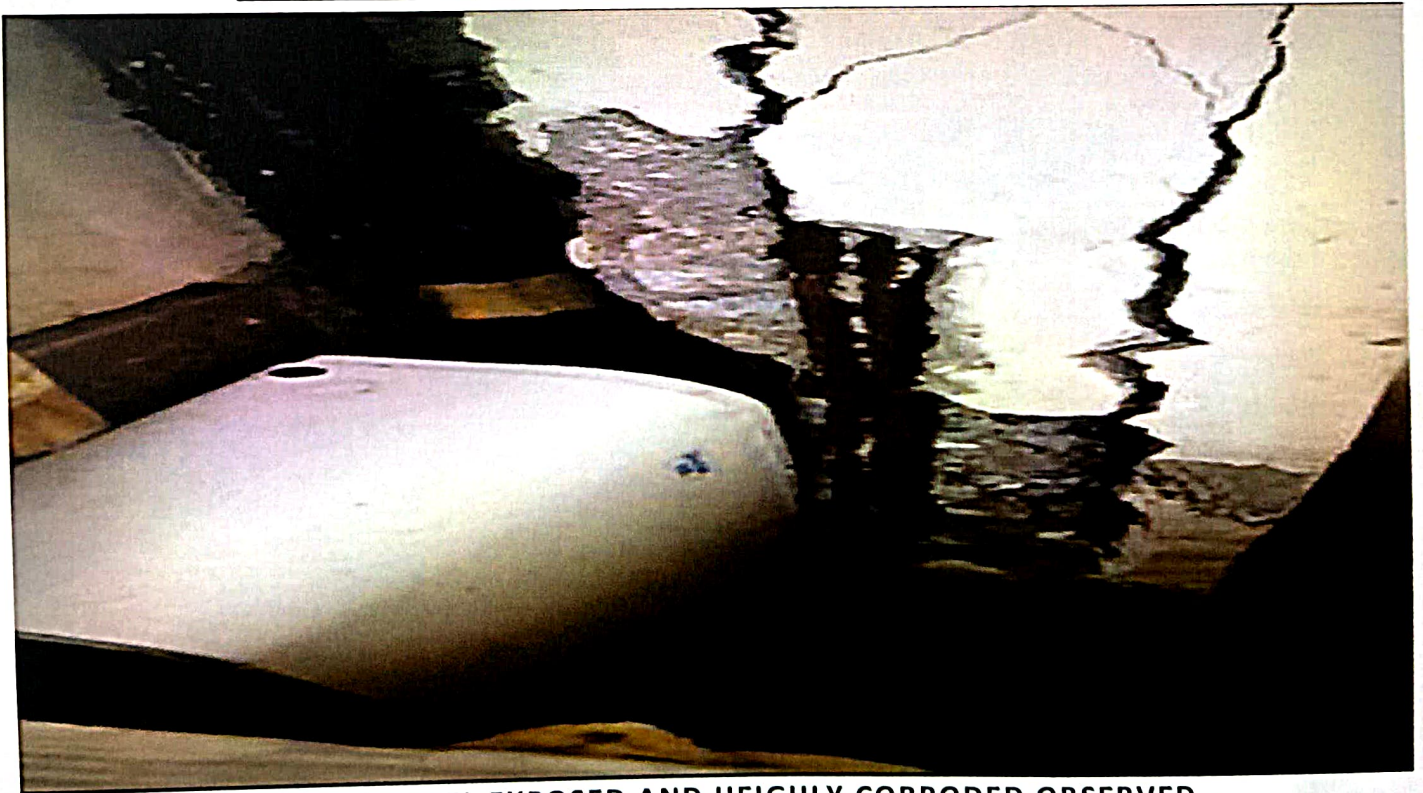
**4. STEEL EXPOSED AND HEIGHLY CORRODED OBSERVED .**

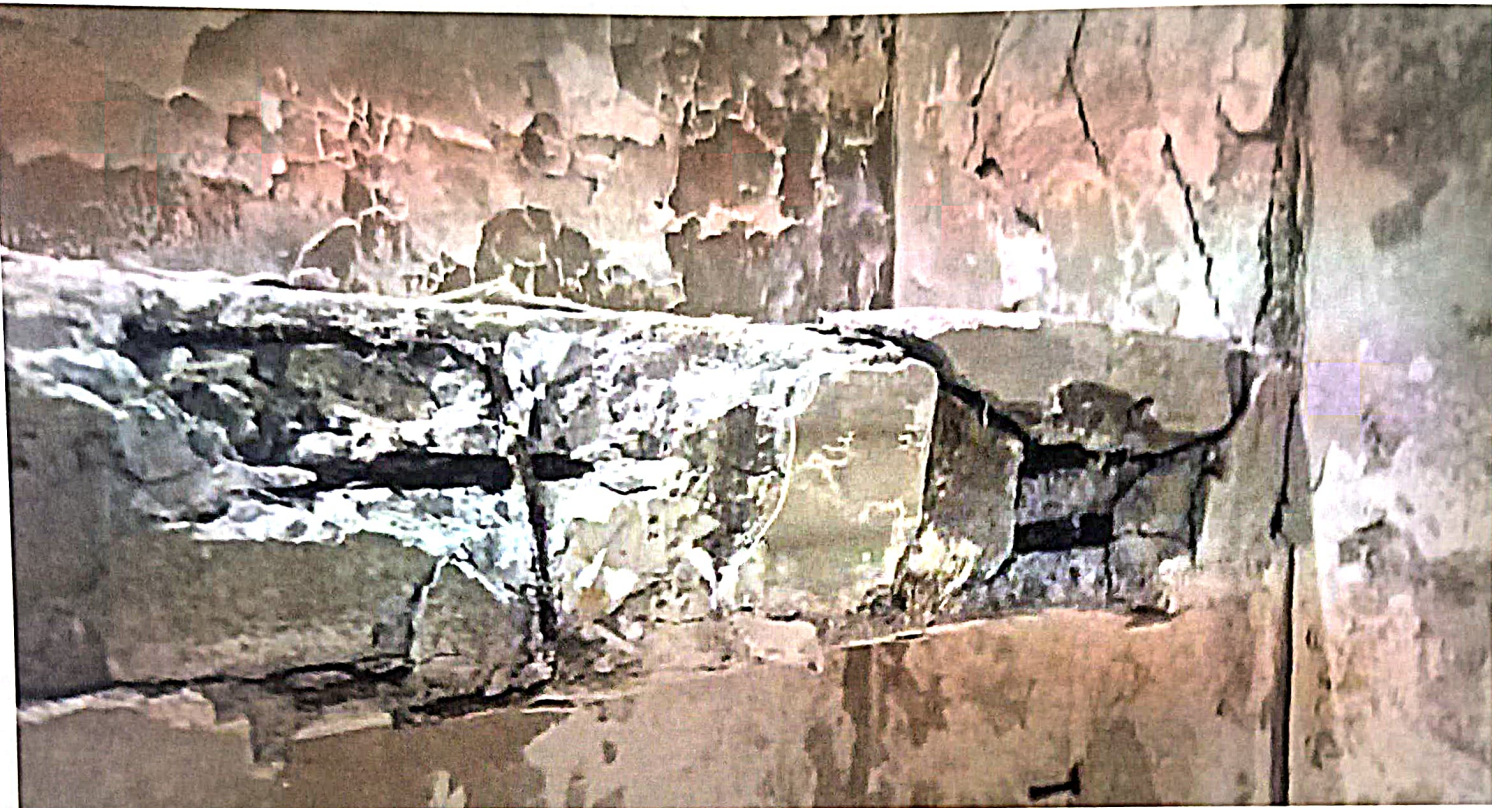
**5. IN SHOP NOTICED BEAM HEIGHLY EXPOSED**

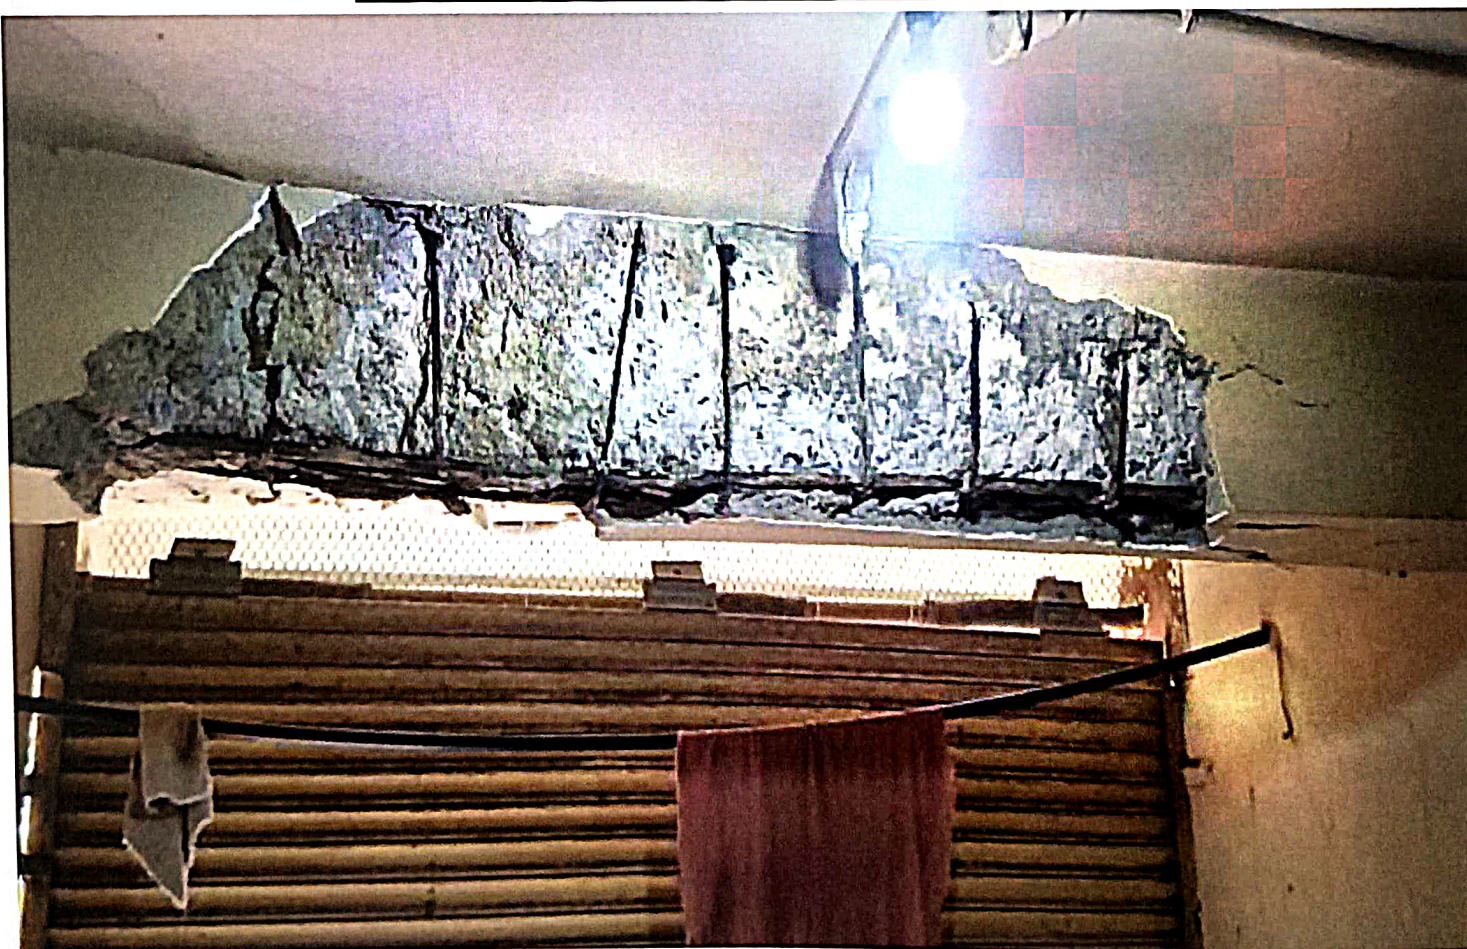
**6. BEAM HEIGHLY EXPOSED HAS BEEN OBSERVED**

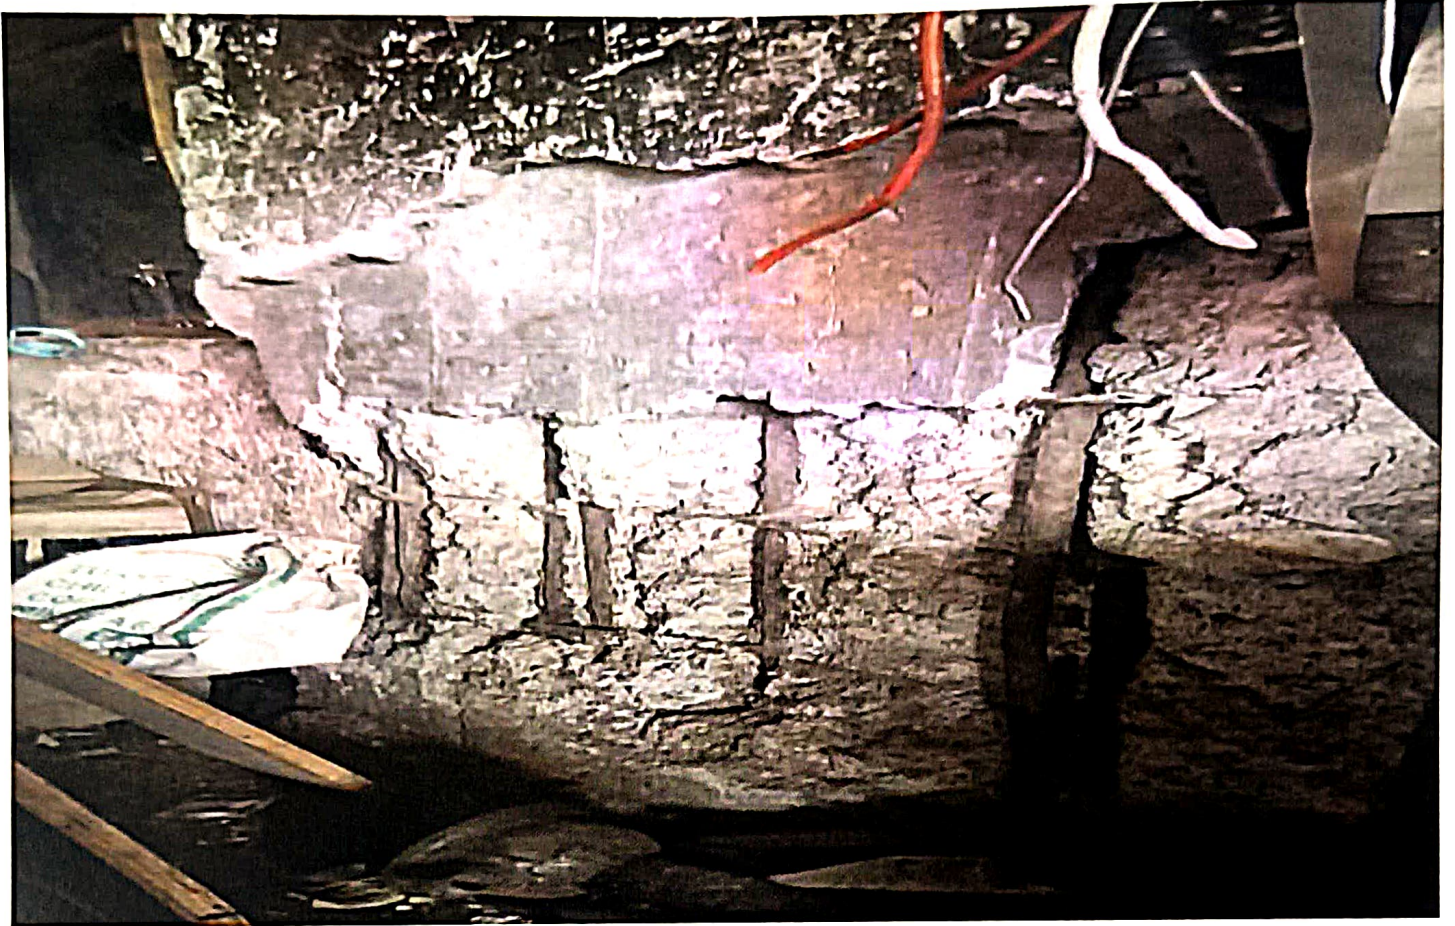
**7. COLUMN HEIGHLY EXPOSED HAS BEEN OBSERVED .**

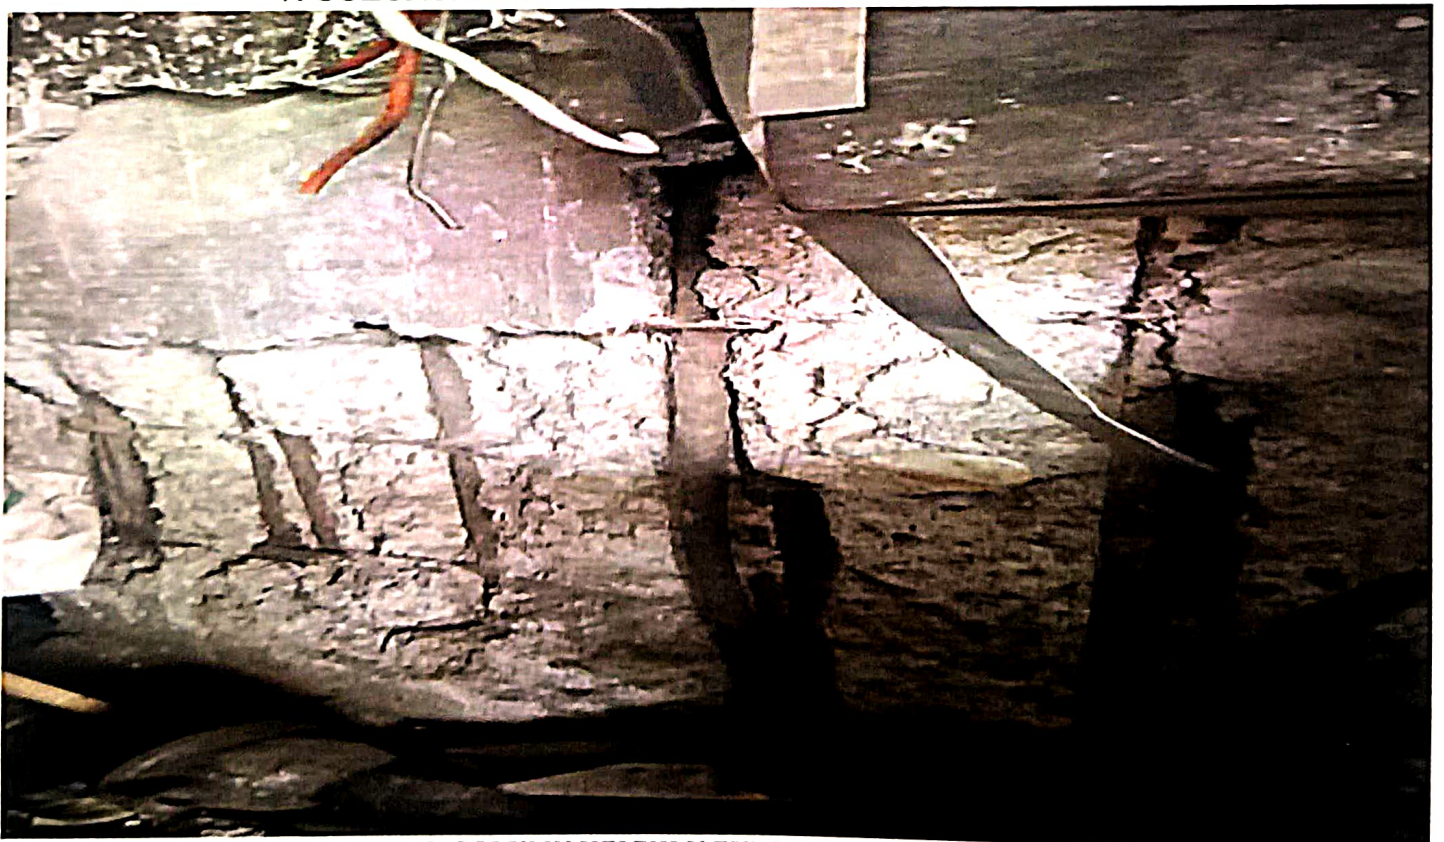
**8. COLUMN HEIGHLY EXPOSED HAS BEEN OBSERVED**

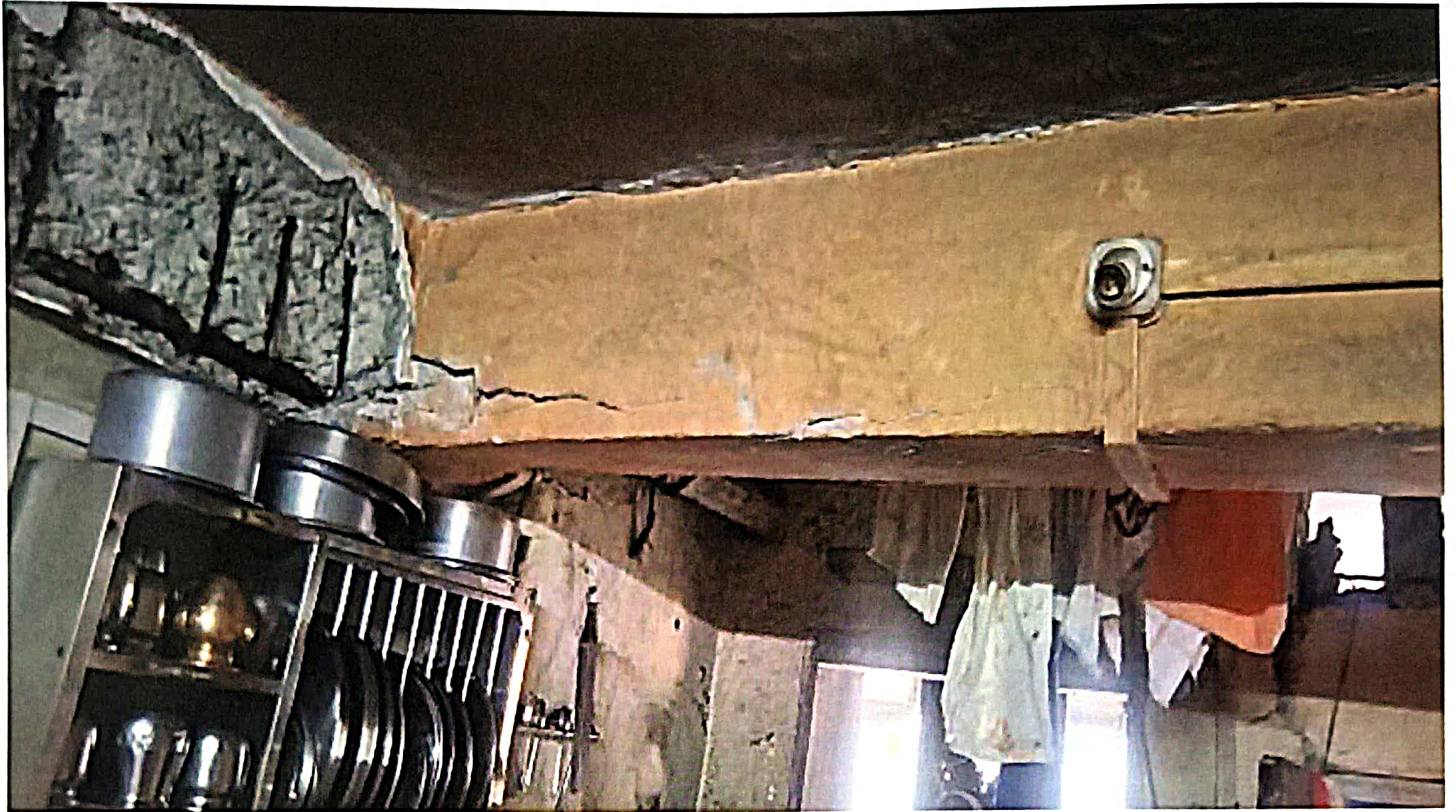
**9. NOTICED BEAM HEIGHLY DAMAGED INSIDE THE GARAGE AREA**

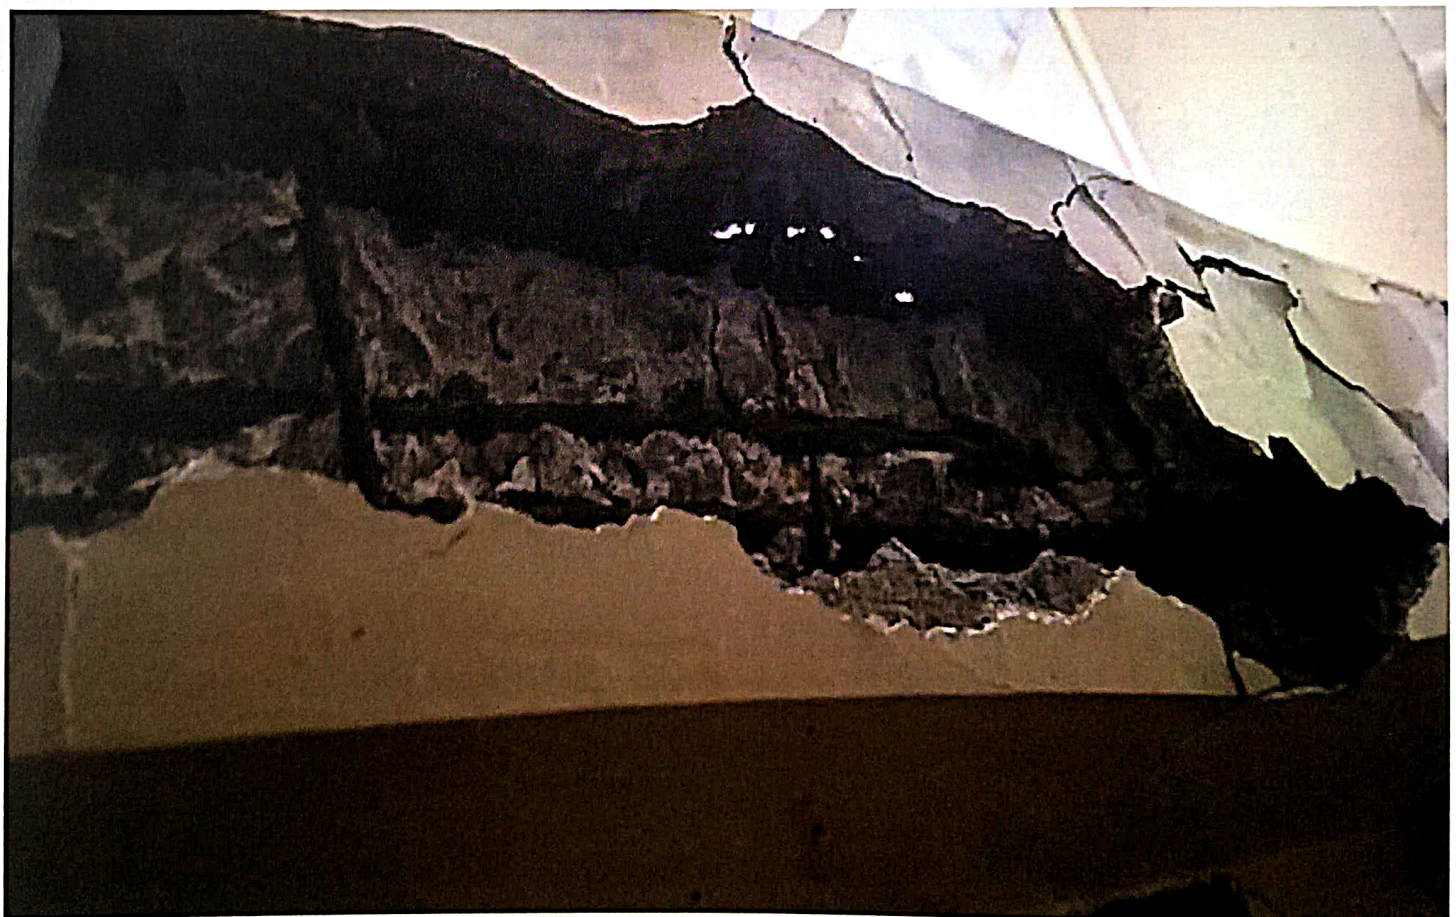
**10. NOTICED BEAM HEIGHLY DAMAGED INSIDE THE GARAGE AREA**
