SUB: SUBMISSION OF STRUCTURAL AUDIT / SURVEY REPORT OF SIMLA HOUSE CHS LTD.

**STATUTORY STRUCTURAL AUDIT REPORT  
OF**

**SIMLA HOUSE CO-OPERATIVE HOUSING SOCIETY LTD.**

**51/B, NEPEAN SEA ROAD, MALABAR HILL, MUMBAI-400026**

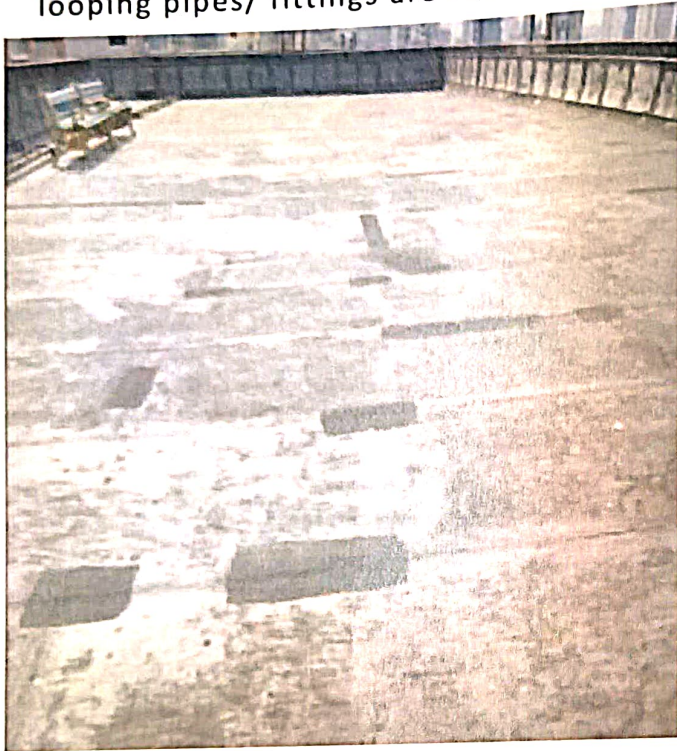
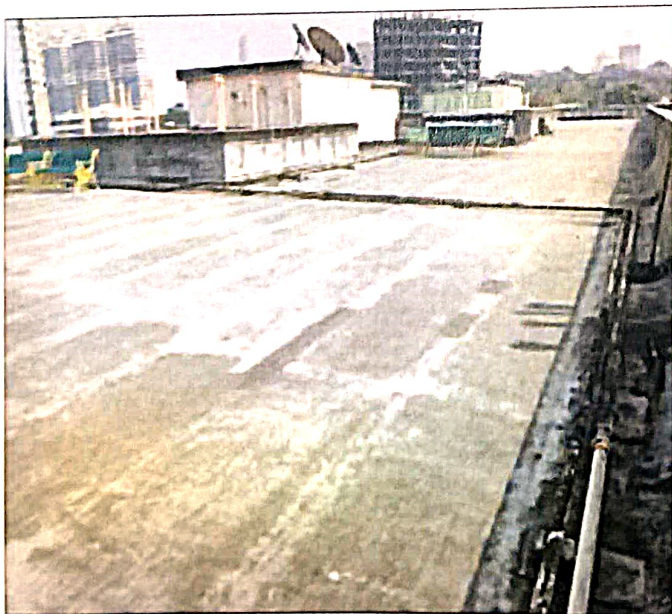
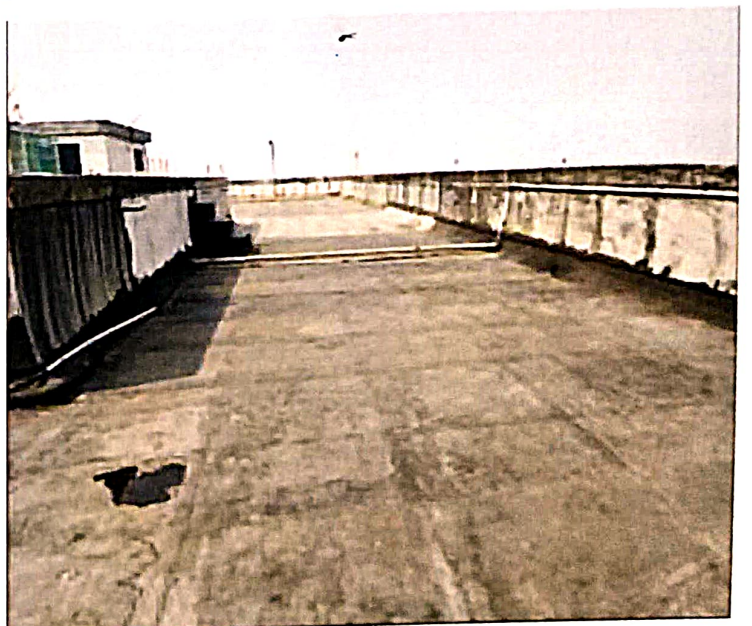
Seepage marks are observed at terrace top floor flats such as flats and hence we conclude that terrace waterproofing of is in bad condition. However, existing terrace flooring is china mosaic Finished. Noticed somewhere Recently Chemical coating was done for temporary relief.

The parapet wall is also seen in moderate condition having minor cracks there was no coping noticed at parapet top. Refer photograph exhibits for more details. G.I looping pipes/ fittings are seen rusted at certain location of terrace area

**TERRACE FLOOR AREA DEVELOPED AIR POCKETS AT MANY PLACES**

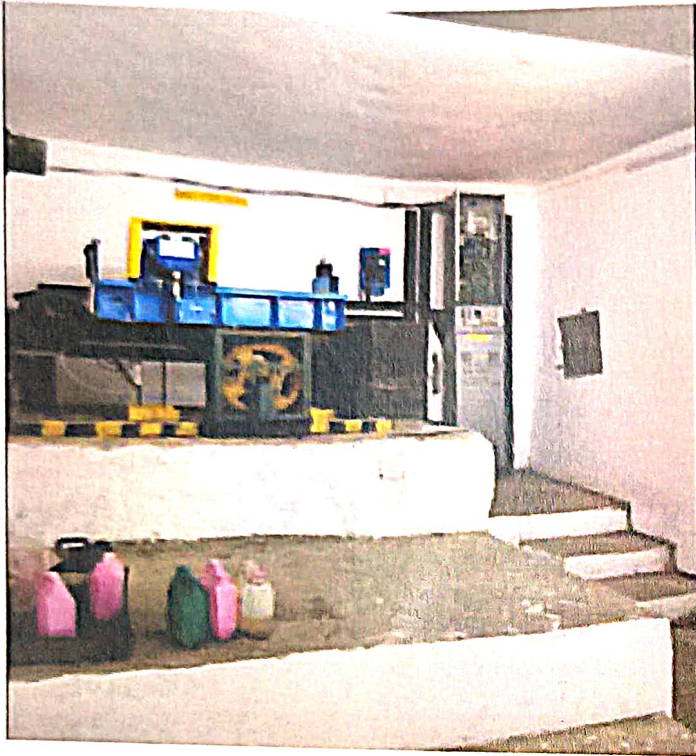
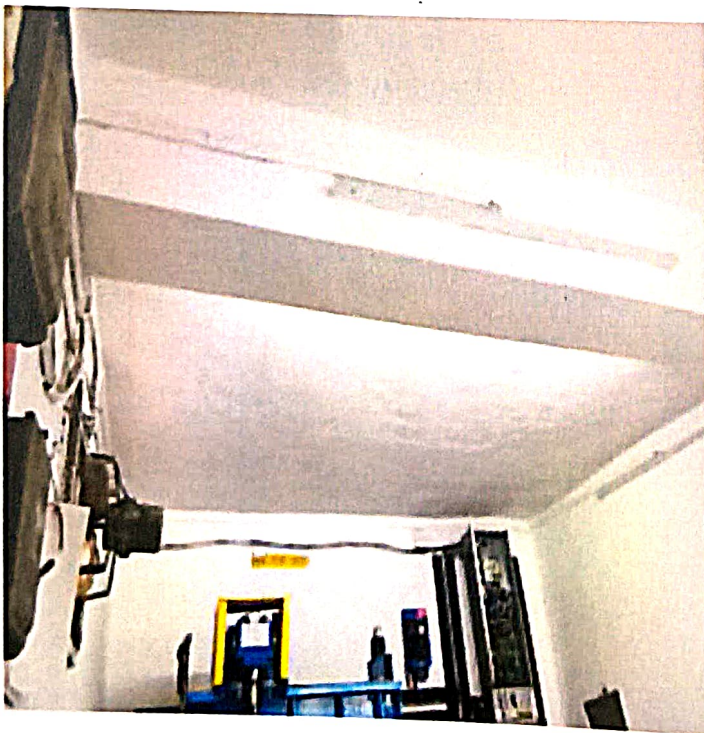
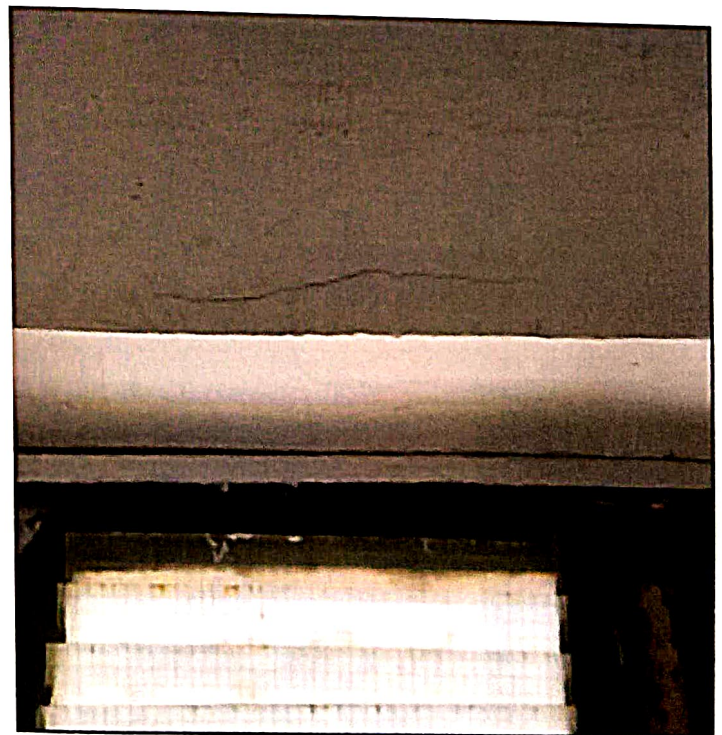
The External condition of overhead lift room is moderate condition. Cracks, crazing and algae growths were noticed at external wall. Reinforcement exposed & failure of concrete. The External condition of overhead room is bad. Cracks, crazing were noticed at external wall.

**LEAKAGES NOTICED IN THE LIFT ROOM AREA**
